Blanco Shutdown April-May 2009

Optics and Opto-mechanics

R.Tighe

CTIO/Optics

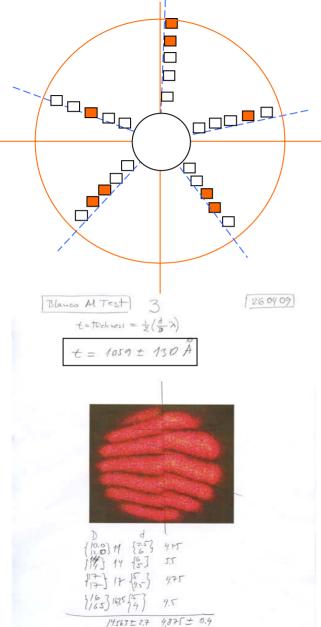
Coating Chamber Testing

1 : Measured Apr 28						
2 : Measured Apr 29						
Thickness monitor final reading = 580A						
Sample	<r1>(%)</r1>	<r<sub>2>(%)</r<sub>	ND	(A)	+/- σ	
1		87.08%	4.55	698	120	
2	83.44%	83.70%	3.75	857	200	
3		89.01%	4.02	1059	130	
4	89.62%	88.94%	3.22	1419	160	
5		89.71%	3.57	1066	160	
6	89.62%	89.76%	3.67			
7		88.11%	4.07	1248	500	
8	8 82.05% 82.58% 3.24			can't measure		
9		88.95%	2.92	can't measure		
10	89.97%	90.03%	3.12	820	160	
11		88.77%	4.10	1332	260	
12	87.39%	87.16%	4.09			
13		83.63%	4.09			
14	88.91%	89.00%	3.06			
15		89.75%	3.28	757	215	
16	89.75%	89.41%	3.97	963	158	
17		87.69%	4.29			
18	85.47%	86.05%	4.01			
19		89.55%	3.54			
20	89.39%	89.75%	3.29			
21	89.03% 4.33		4.33			
22	84.95% 85.35% 4.18					
23		89.47%	4.41			
24	90.09%	90.22%	3.81			
25		89.99%	3.82			
Average all		88.1%	3.8	1021.9	206.3	
Average R	Goal		90%-91%	900-1000	AC	
Coating	Oct02		88.81%			
Coating	July04		89.60%

The low reflectance must be due to contamination because the ND, the Coating Thickness Monitor and the Film Thickness Interferogram measurements say the layer thickness is OK.

Decided not to re-coat the Blanco main mirror and wash it instead given that the coating is in good condition:

Av.R=88.3%,TIS=0.85% (new Aluminium coating: R= 89.6%,TIS=0.35%).-

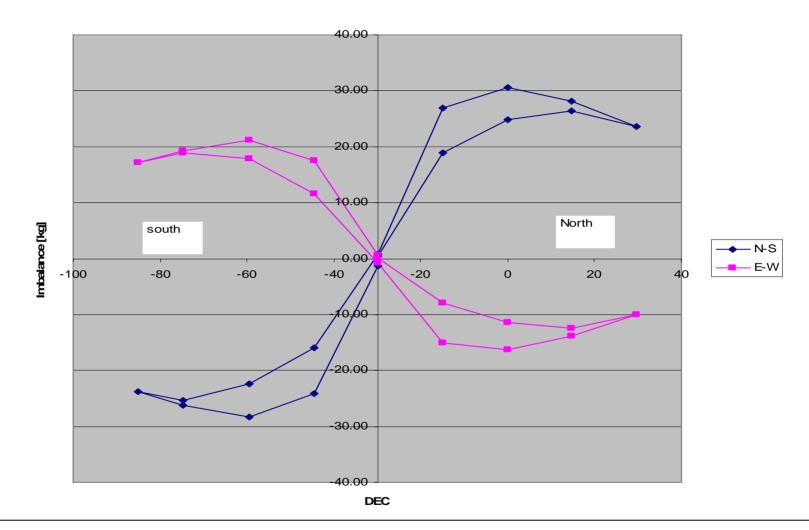
Balance: Mirror to Counterweights

Imbalance of ~30Kg means the M1 is "heavier" than the counterweights by that amount. But adding the missing mass to the counterweights made no significant difference. Moreover the max. amplitude happens at Zd~30°. To be studied.

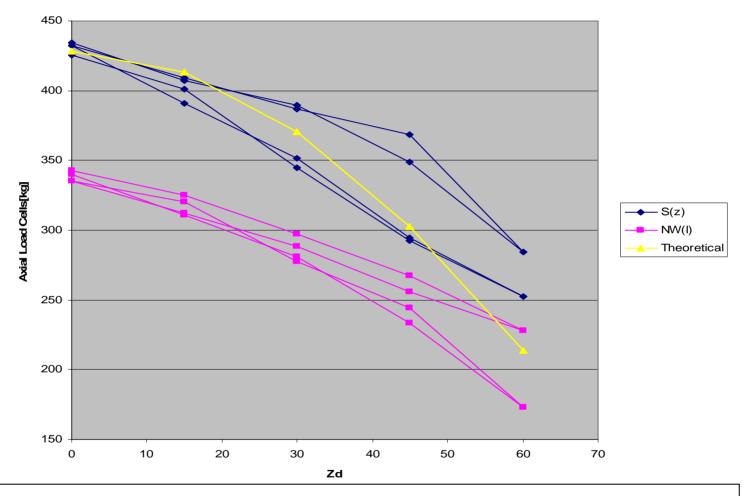
The Axial Load Cells

Results not too different from measurements done in the past but: i) load cells had been re-calibrated so why the discrepancy?...and ii) Is the missing load cell taking a higher load?. Measurements should be done again. Now that all 3 load cells are working and M1 is free from the radial defining points.

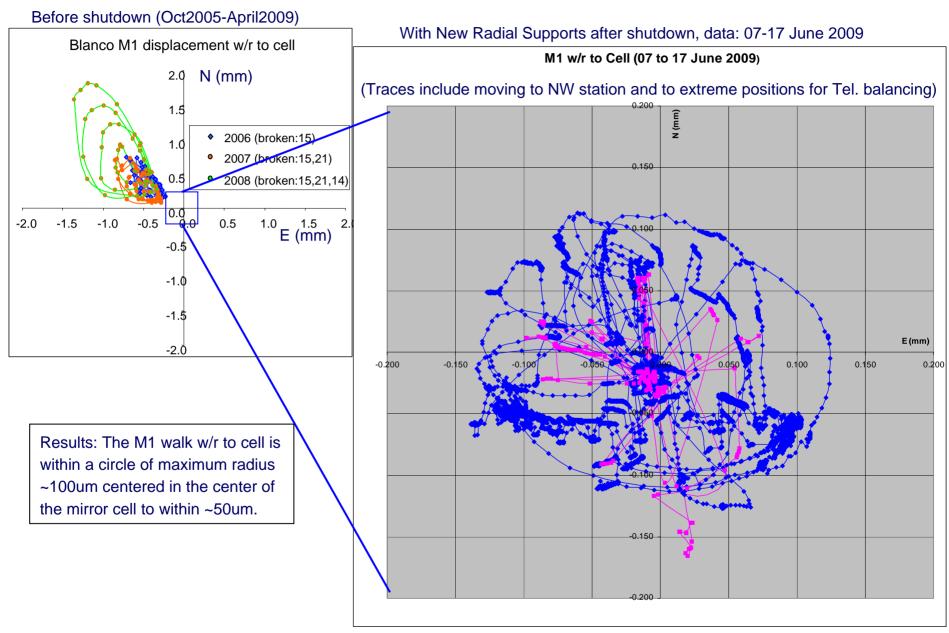
M1 displacement w/r to M1 Cell

M1 displacement w/r to cell is ~ 1/4 the max. tolerance for coma (~500um).

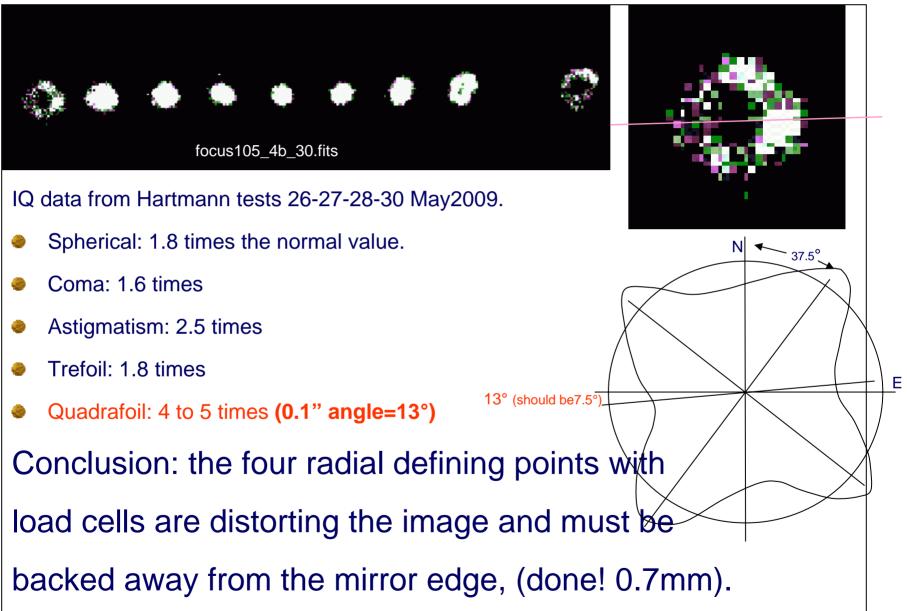
IQ measurements: analysis and action taken

- IQ measurements: Hartmann testing at PF with radial defining points pressed against mirror edges with average force of ~80kg per load cell. Results: strong astigmatic features, decided to remove the radial defining points.

4map Baseline Corrections

PF:	new		old	
	b0=0		b0=0	
	b2=500	70 (should be put back to old)	b2=400	15
	b3=0	0	b3=0	0
	b4=0	0	b4=0	0
● F/8:	new		old	
	b0=0		b0=0	
	b2=940	340	b2=940	340
	b3=270	349	b3=270	349
	b4=100	180	b4=100	180
