SOAR 2018 Shutdown Details

Last update Nov. 20, 2018

M2 Removal

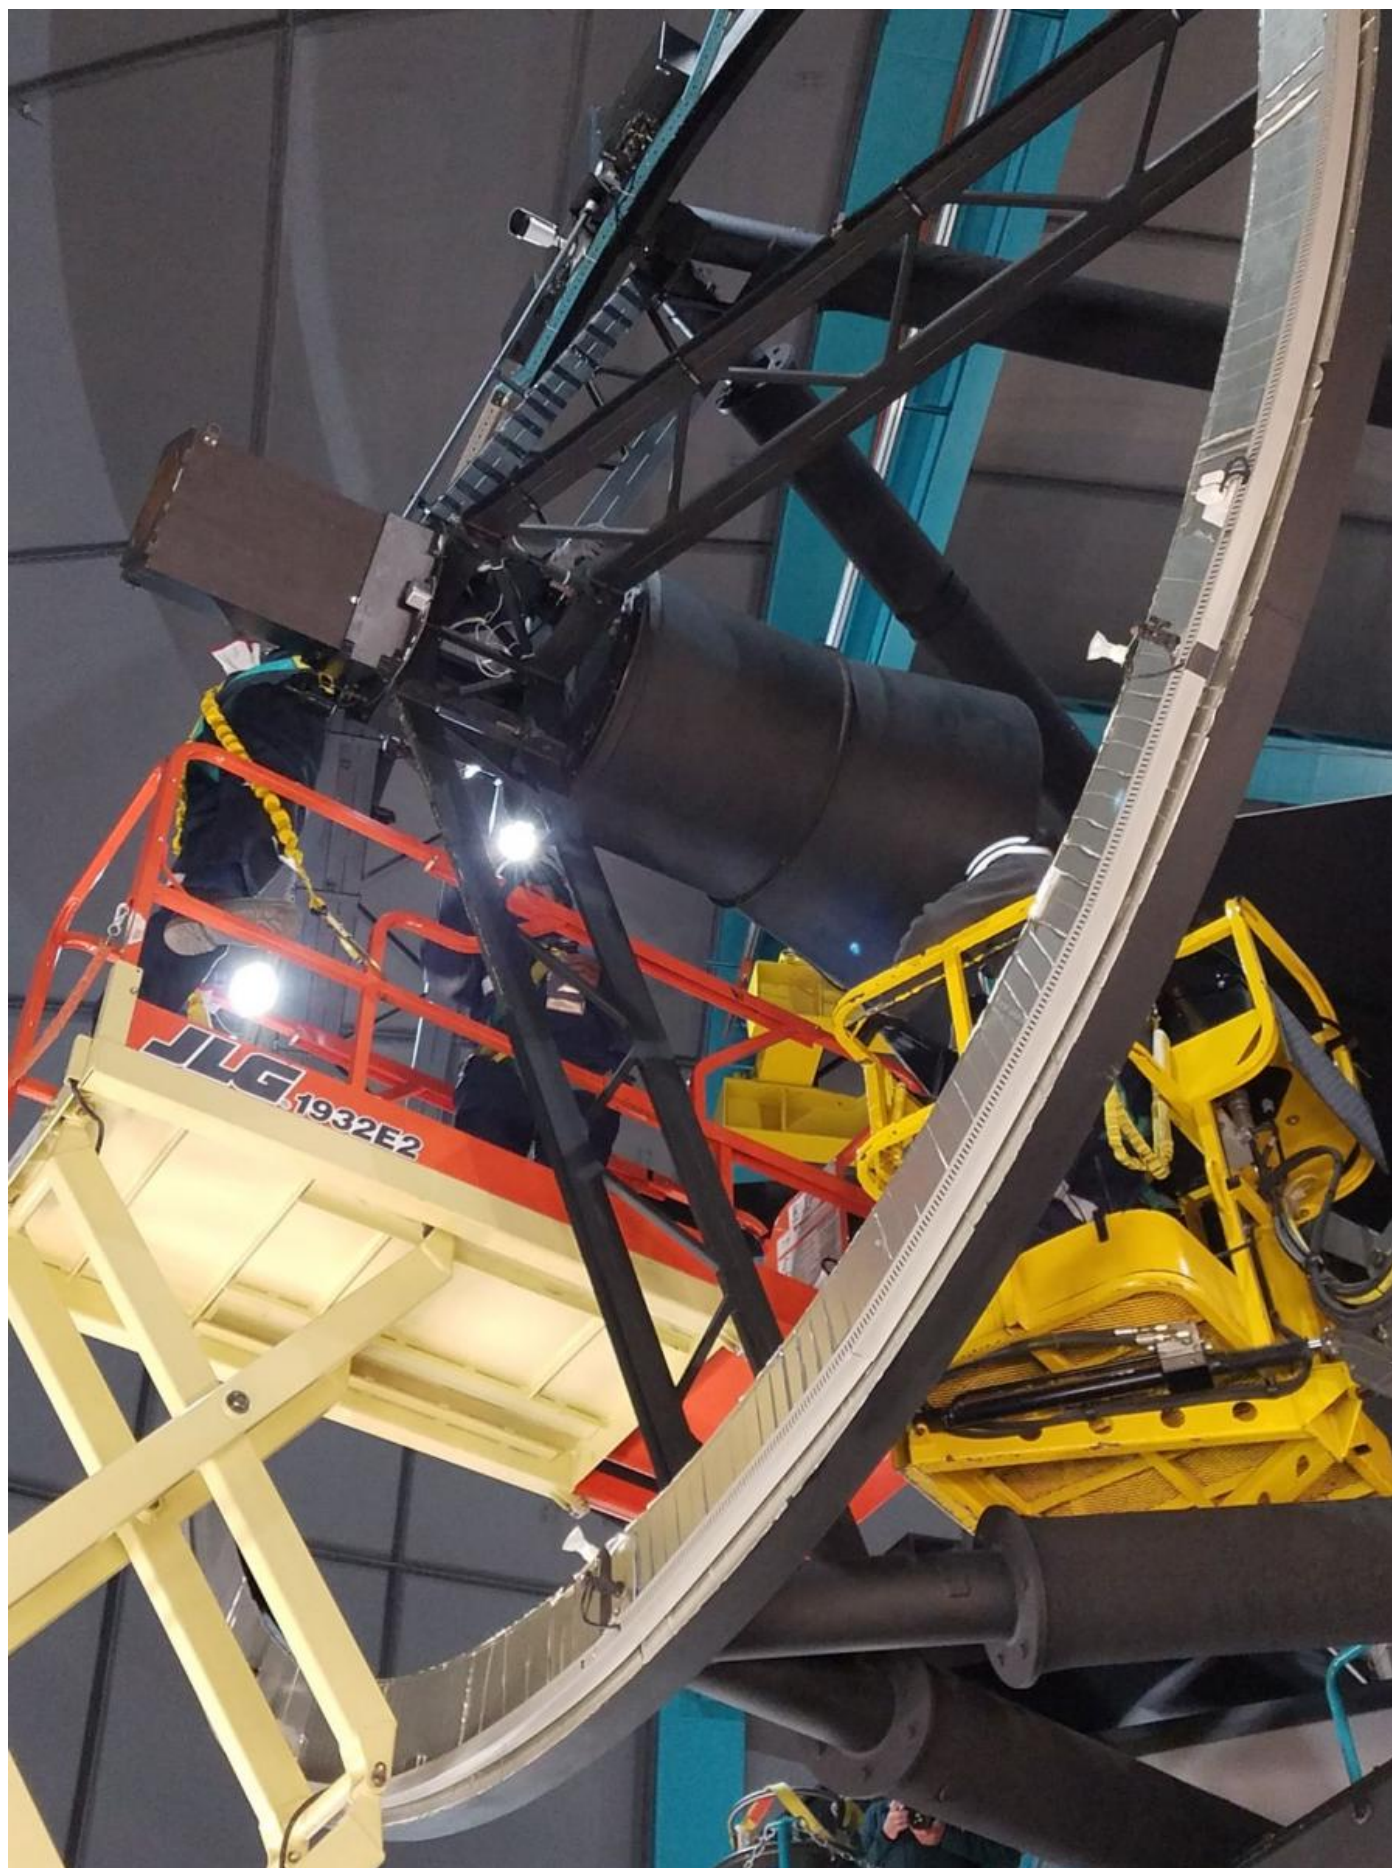
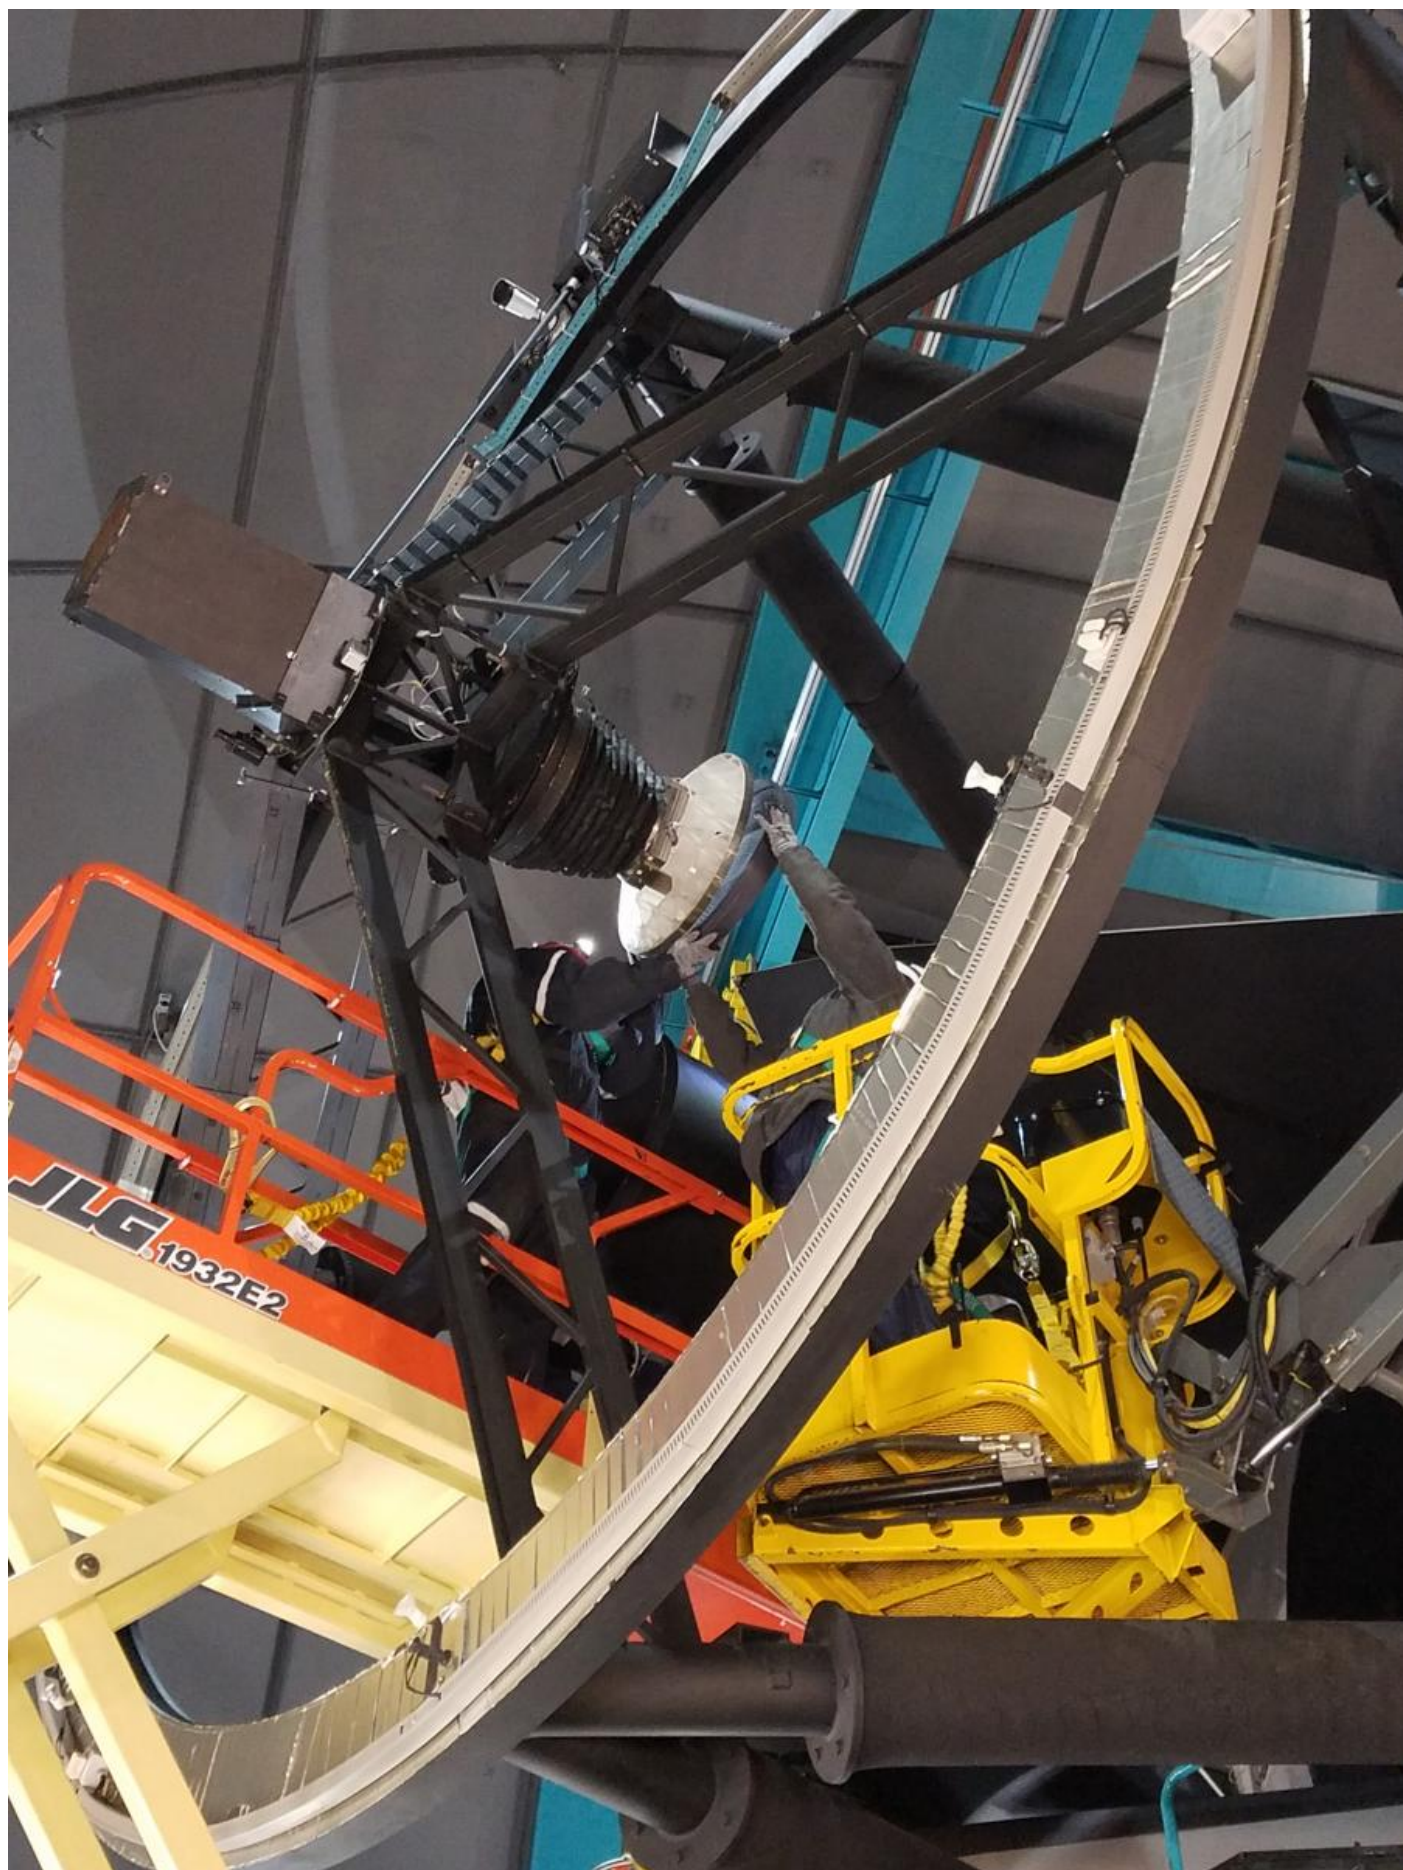
In the left-hand picture, the telescope crew is using a scissor lift and boom lift to access the baffle around the secondary mirror assembly; in the right-hand picture the baffle has been removed and the crew is placing a protective cover over the mirror.

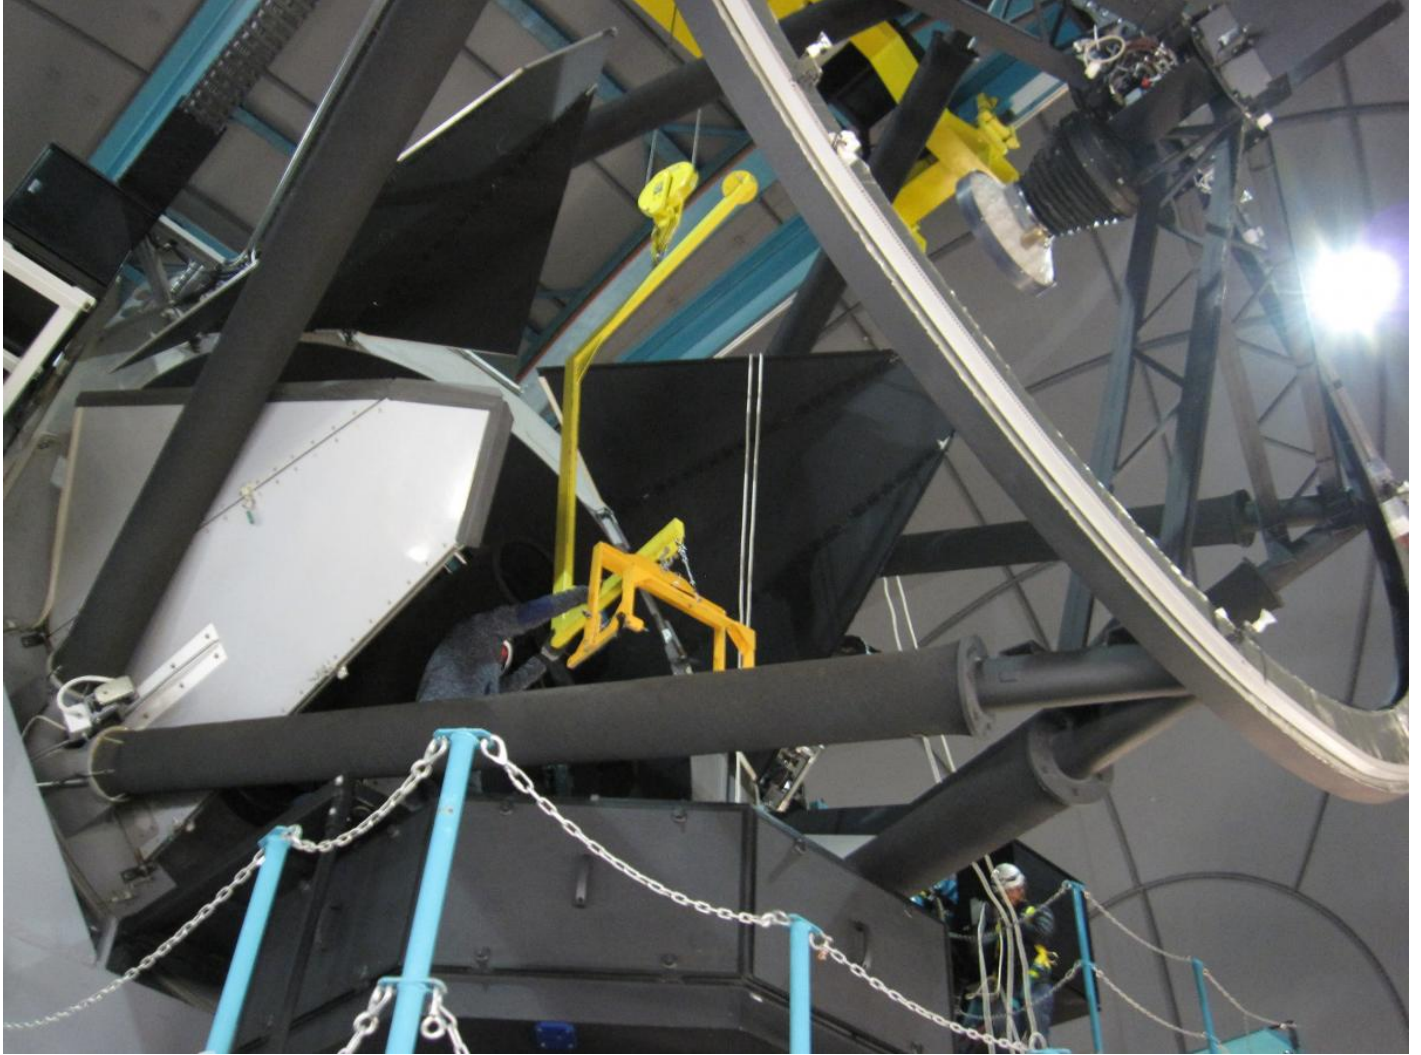
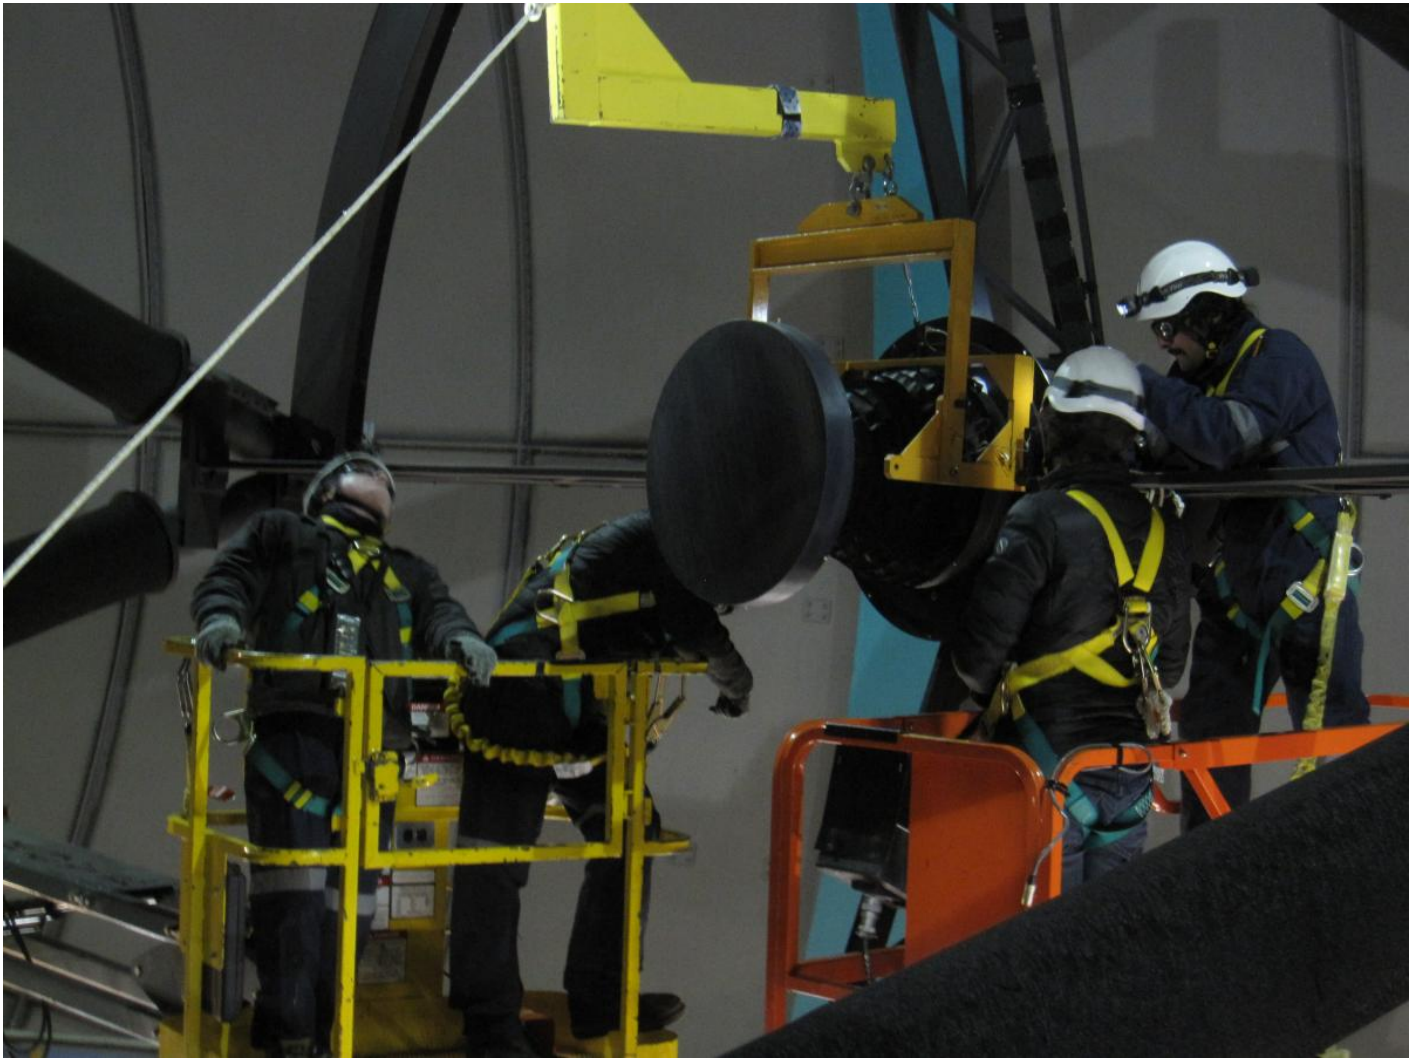
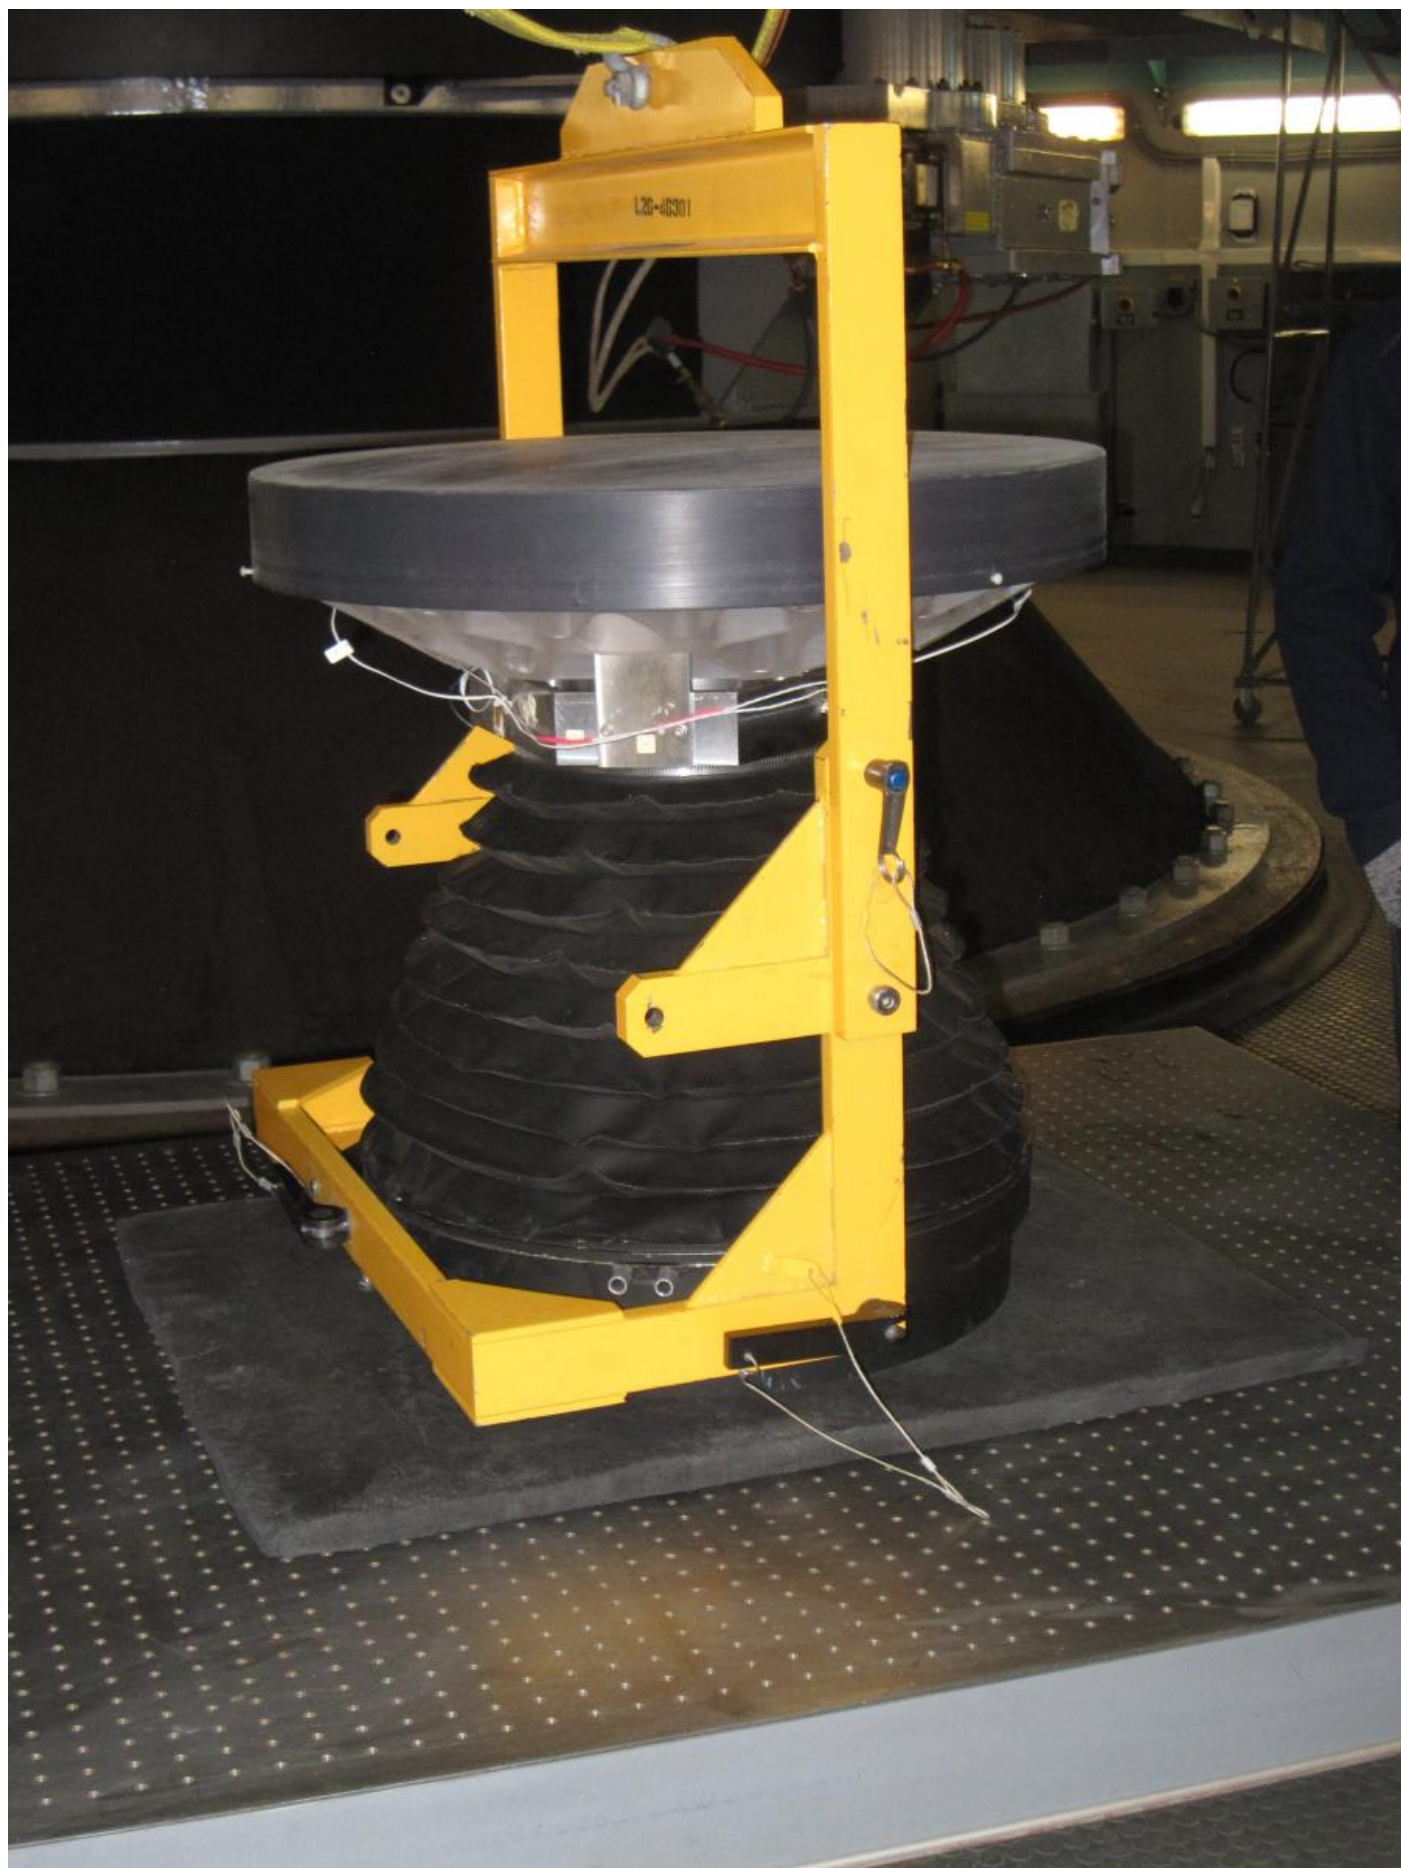
The subsequent steps require attaching a special lifting fixture to the M2 assembly, detaching the assembly from the telescope structure, and then moving it to an optical table where the mirror can be removed (next three pictures):

At this point the mirror was removed and placed in its transport box, to be taken over to the 1.5-m coating plant on Cerro Tololo. There it was coated (shown later, below). At the same time, removal of M3 took place, also shown below

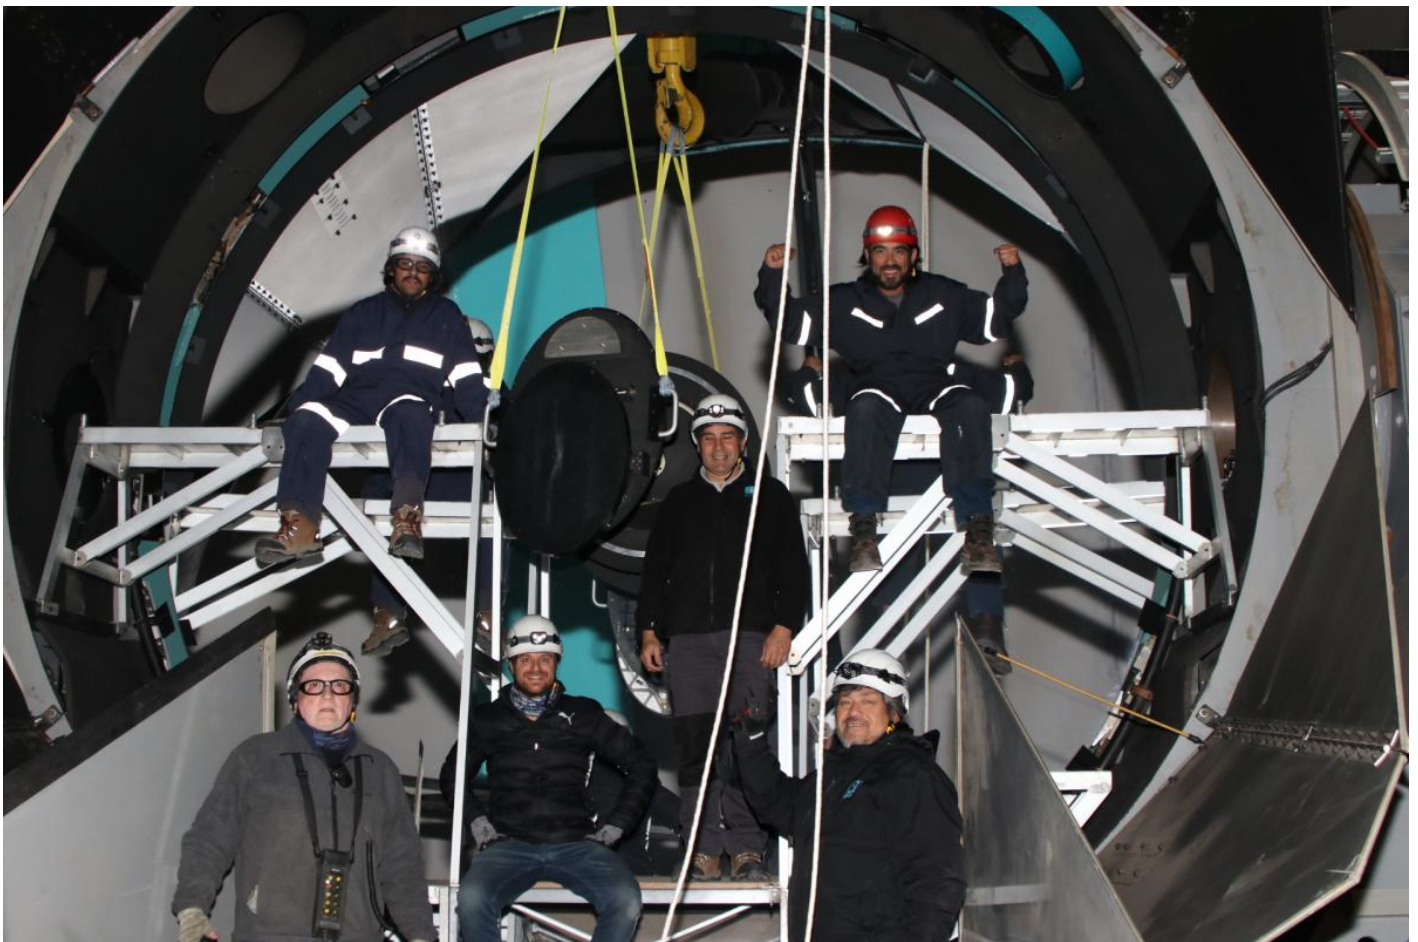
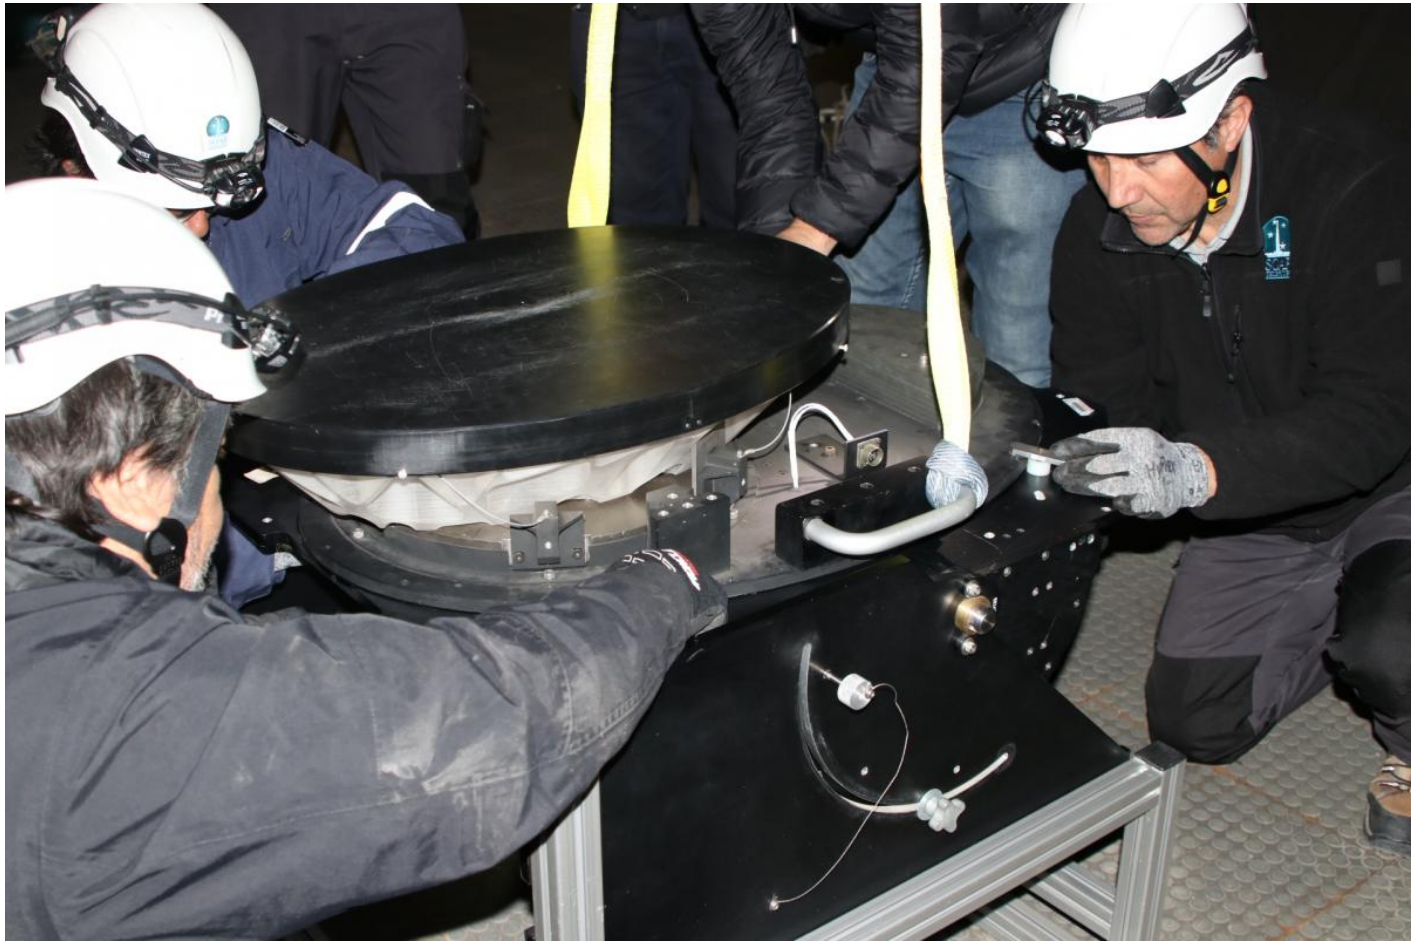
The process for removing M3 is generally similar for that for M2, except that less of the assembly needed to be removed. The pictures below show the M3 tip-tilt assembly being removed from the M3 turret, and then the assembly on the optical bench. The mirror-handling crew in the left-hand picture are (top) Mauricio Araya, Manuel Torres and Cristian Diaz; (bottom) Eduardo Aguirre, Jose Piraces and Fabian Collao.

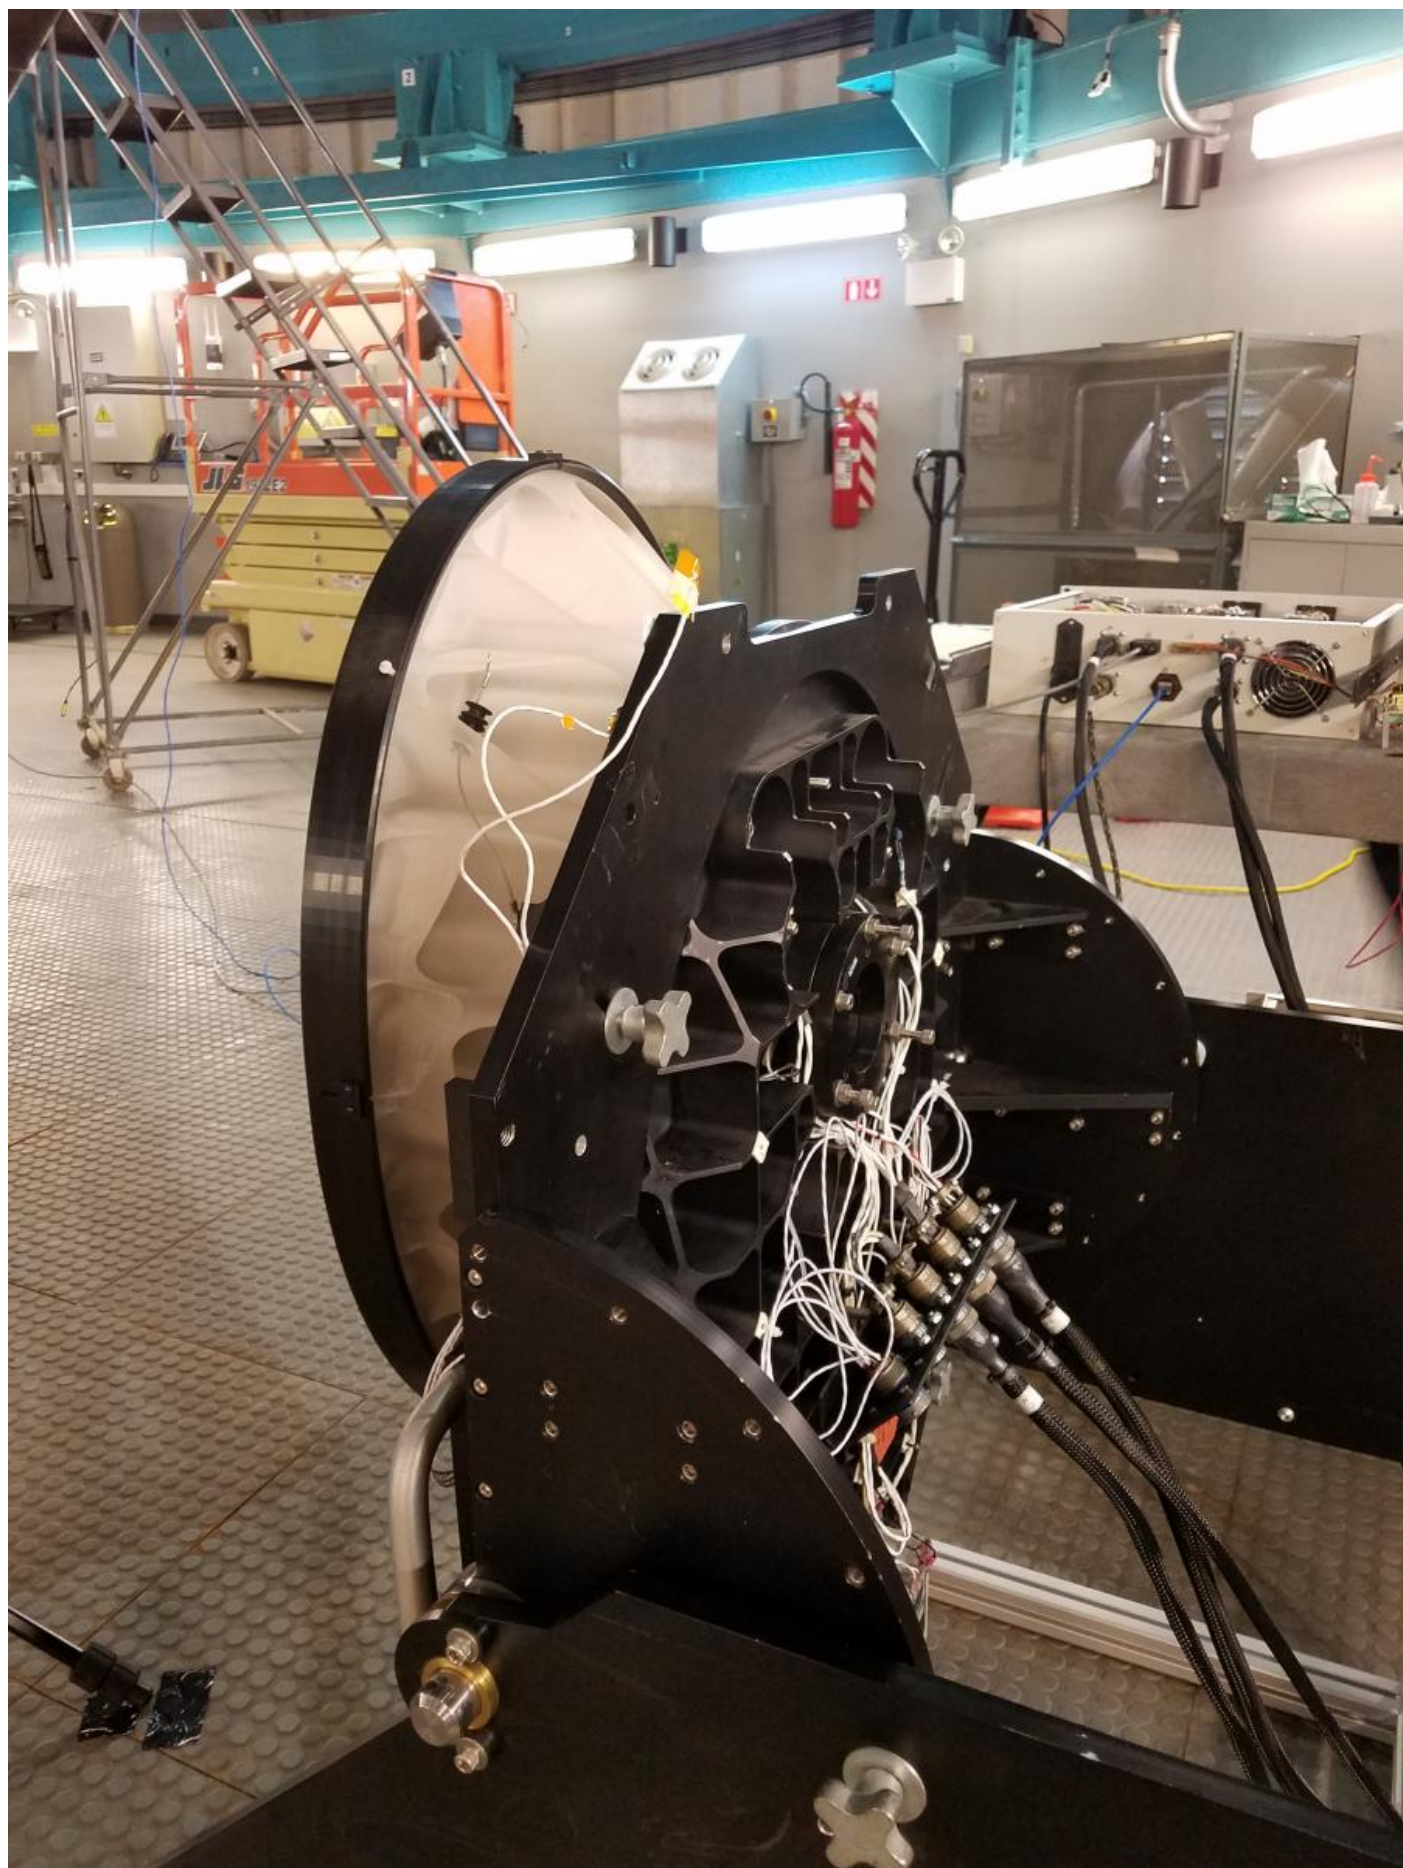
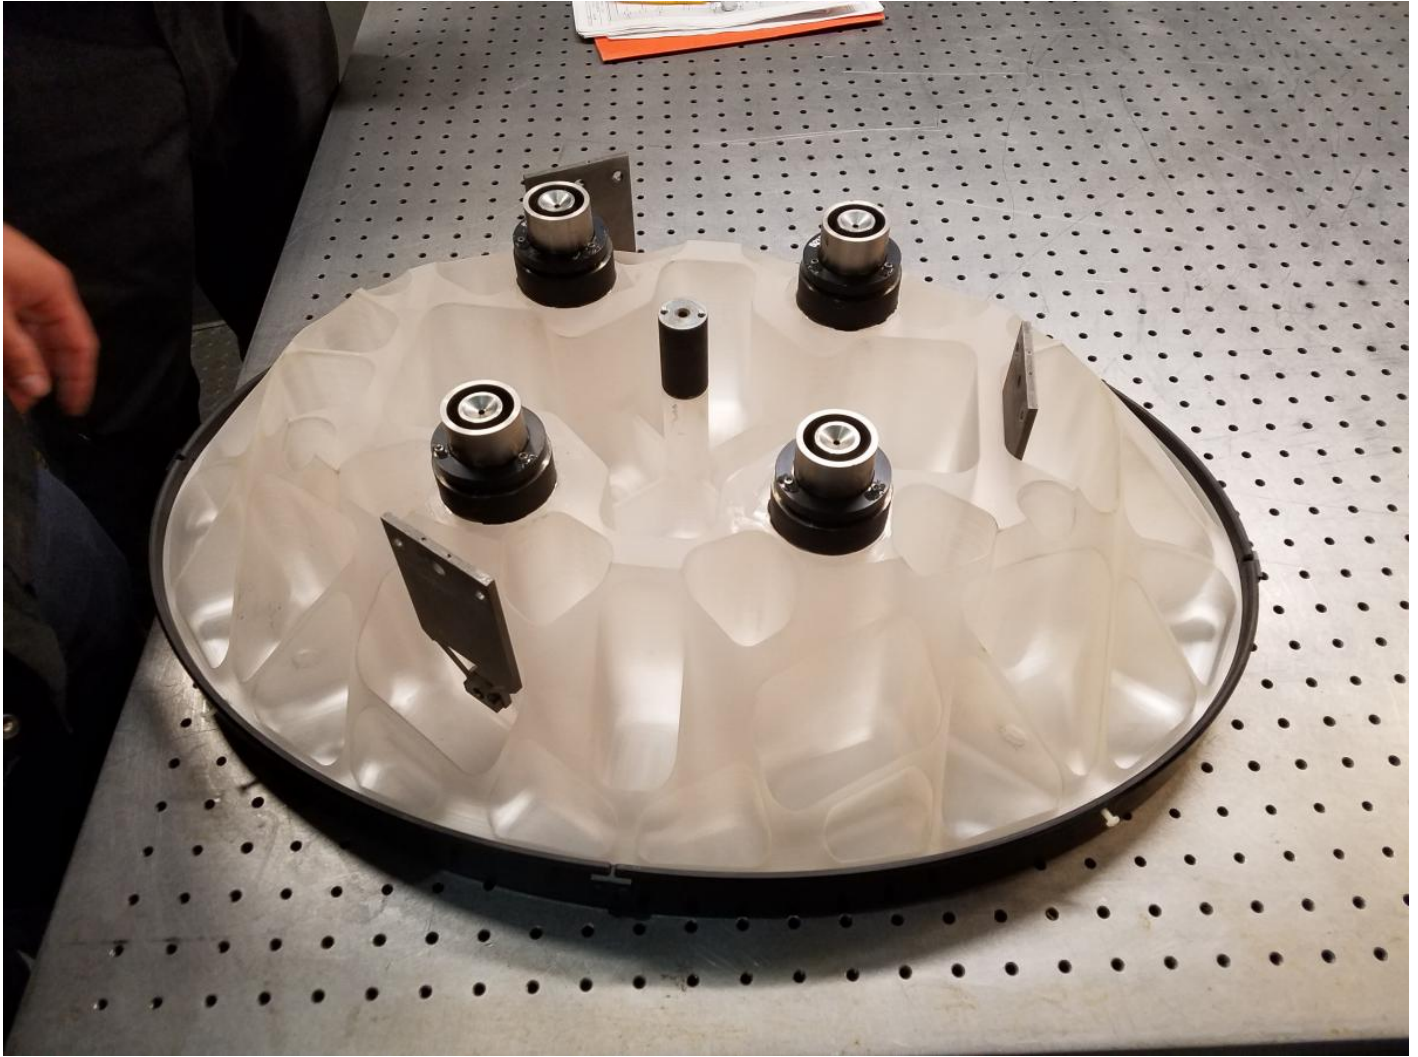
The next photos show the tip-tilt assembly undergoing a set of benchmark measurements that are intended to aid re-assembly, followed by a picture of the mirror (and cover) after it has been removed from the assembly.

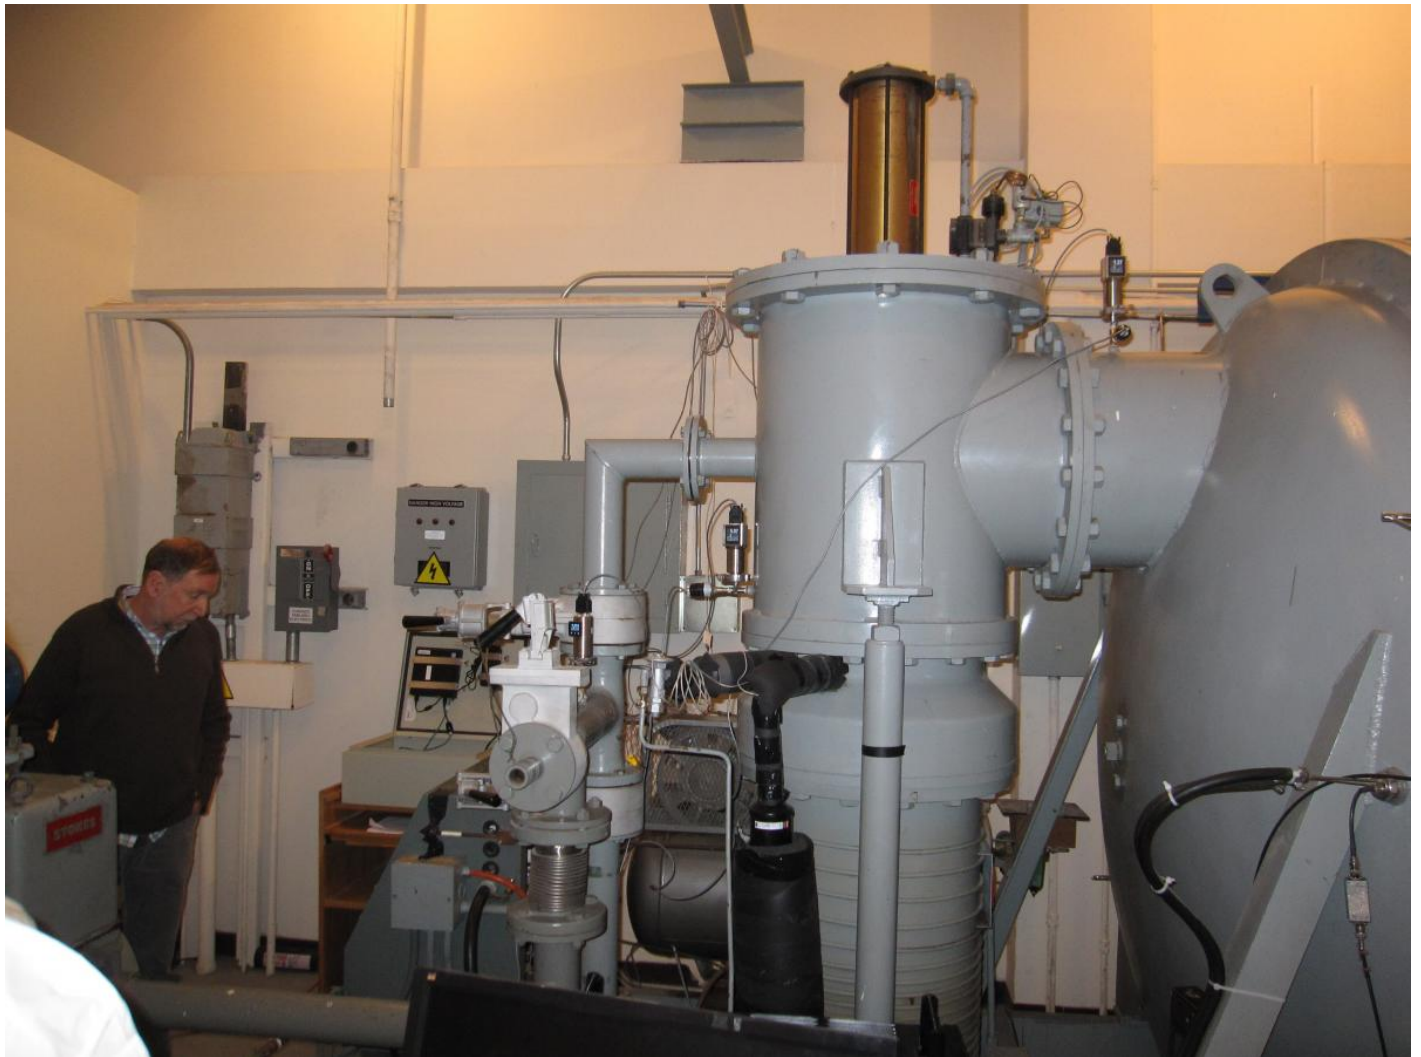
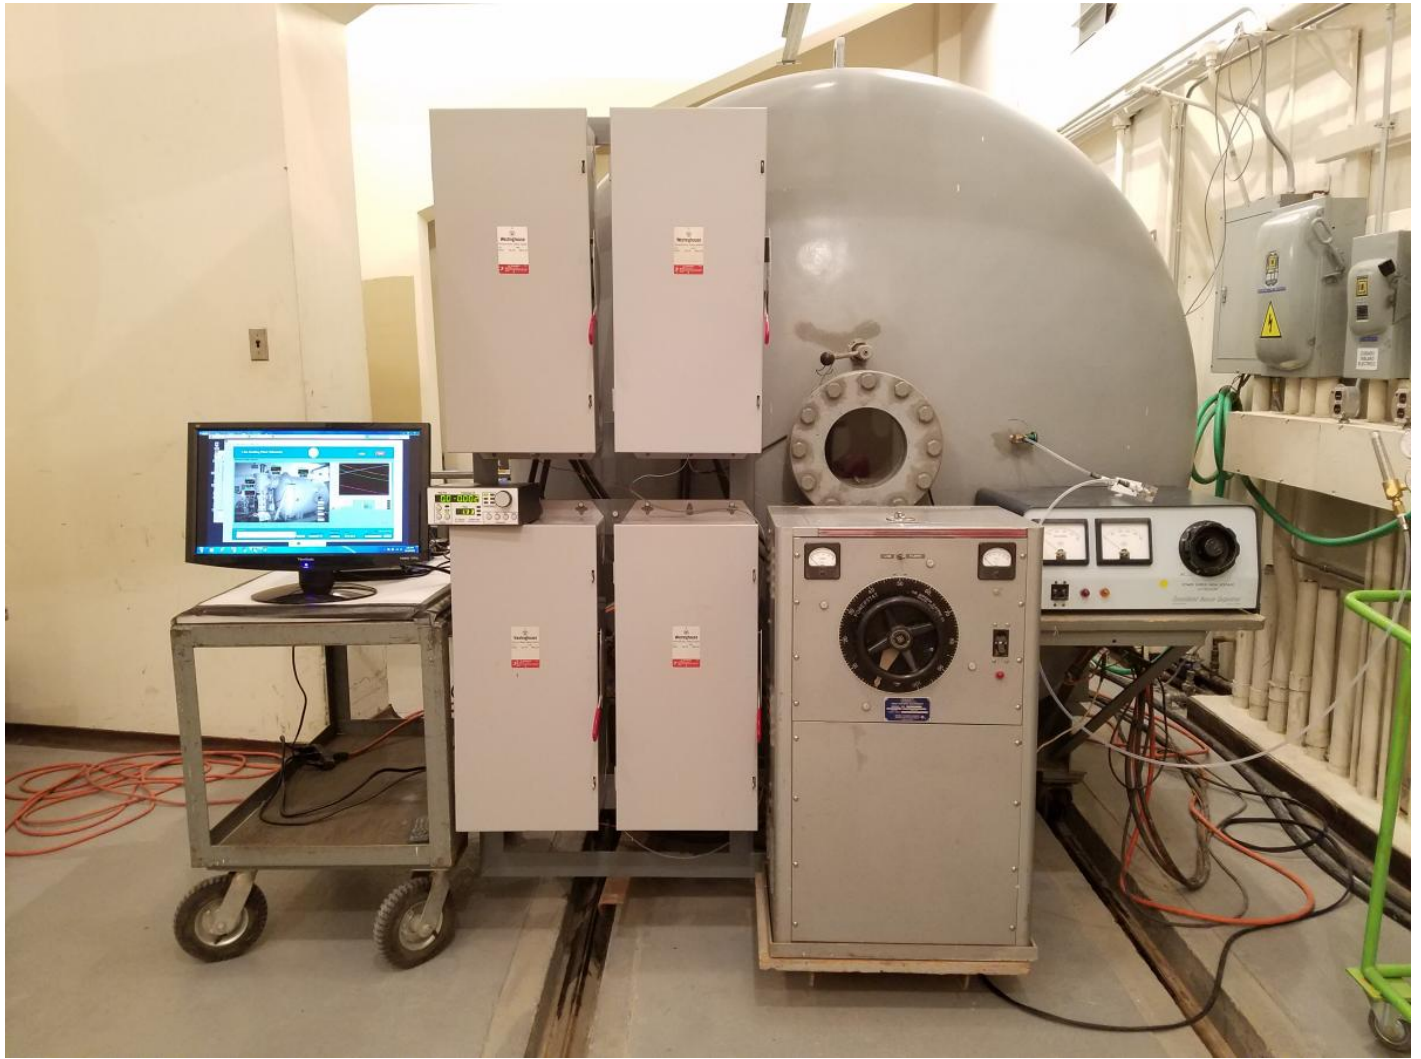
First, the coating tank itself (vacuum systems at left, filament controls and view port on the right); Roberto Tighe operating the plant.
