SOAR 2018 Shutdown Details

Last update Nov. 20, 2018

M2 Removal

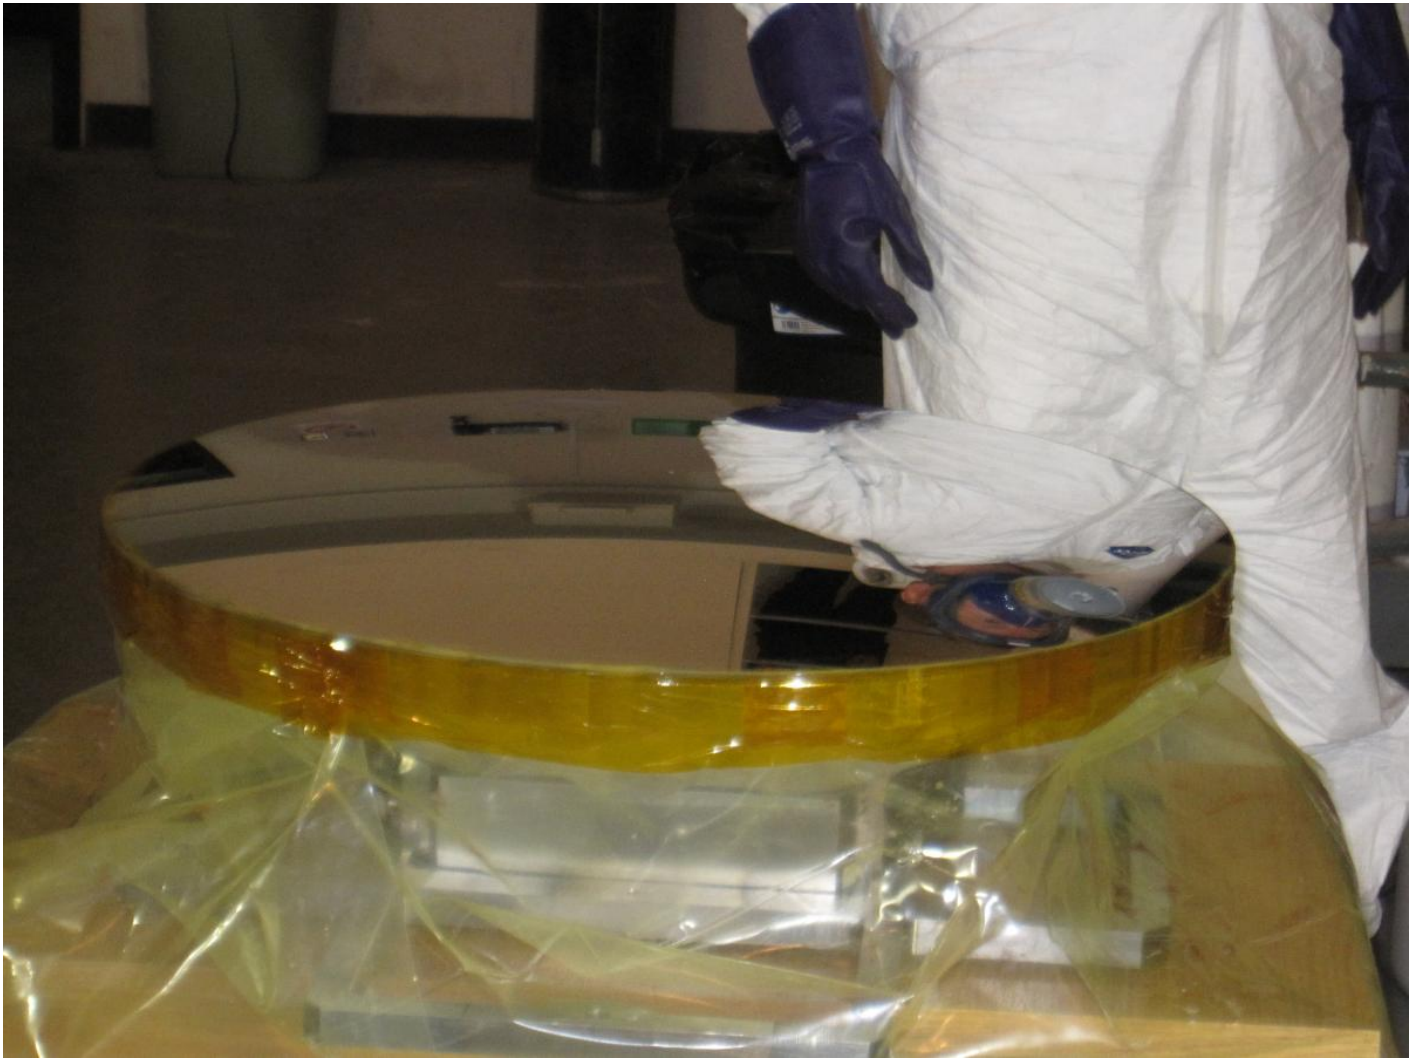
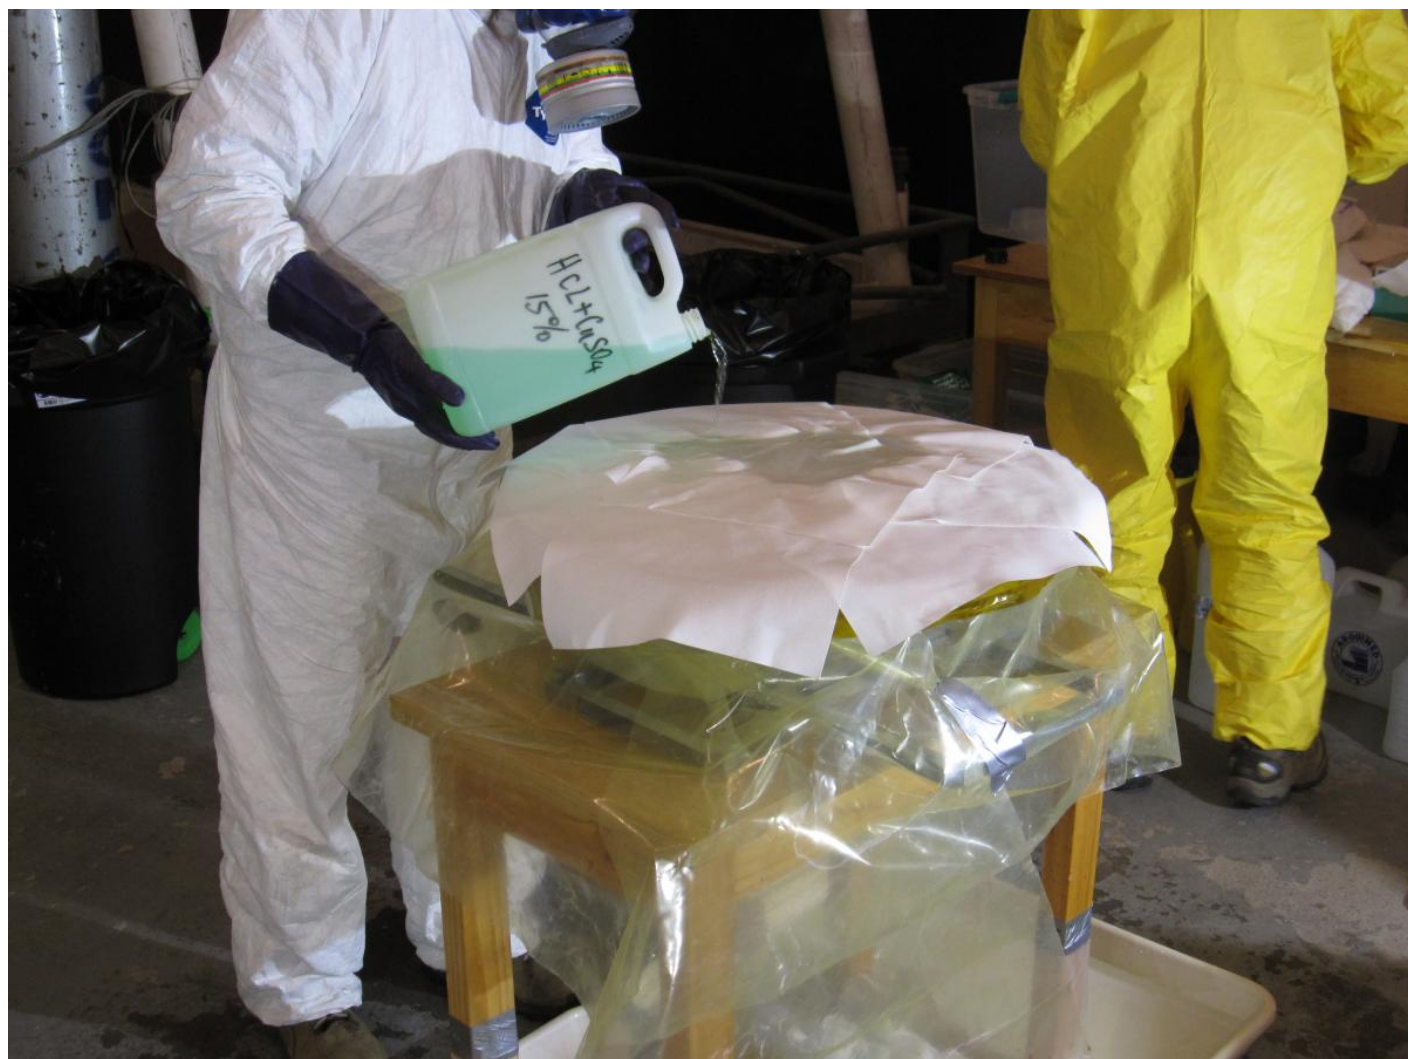
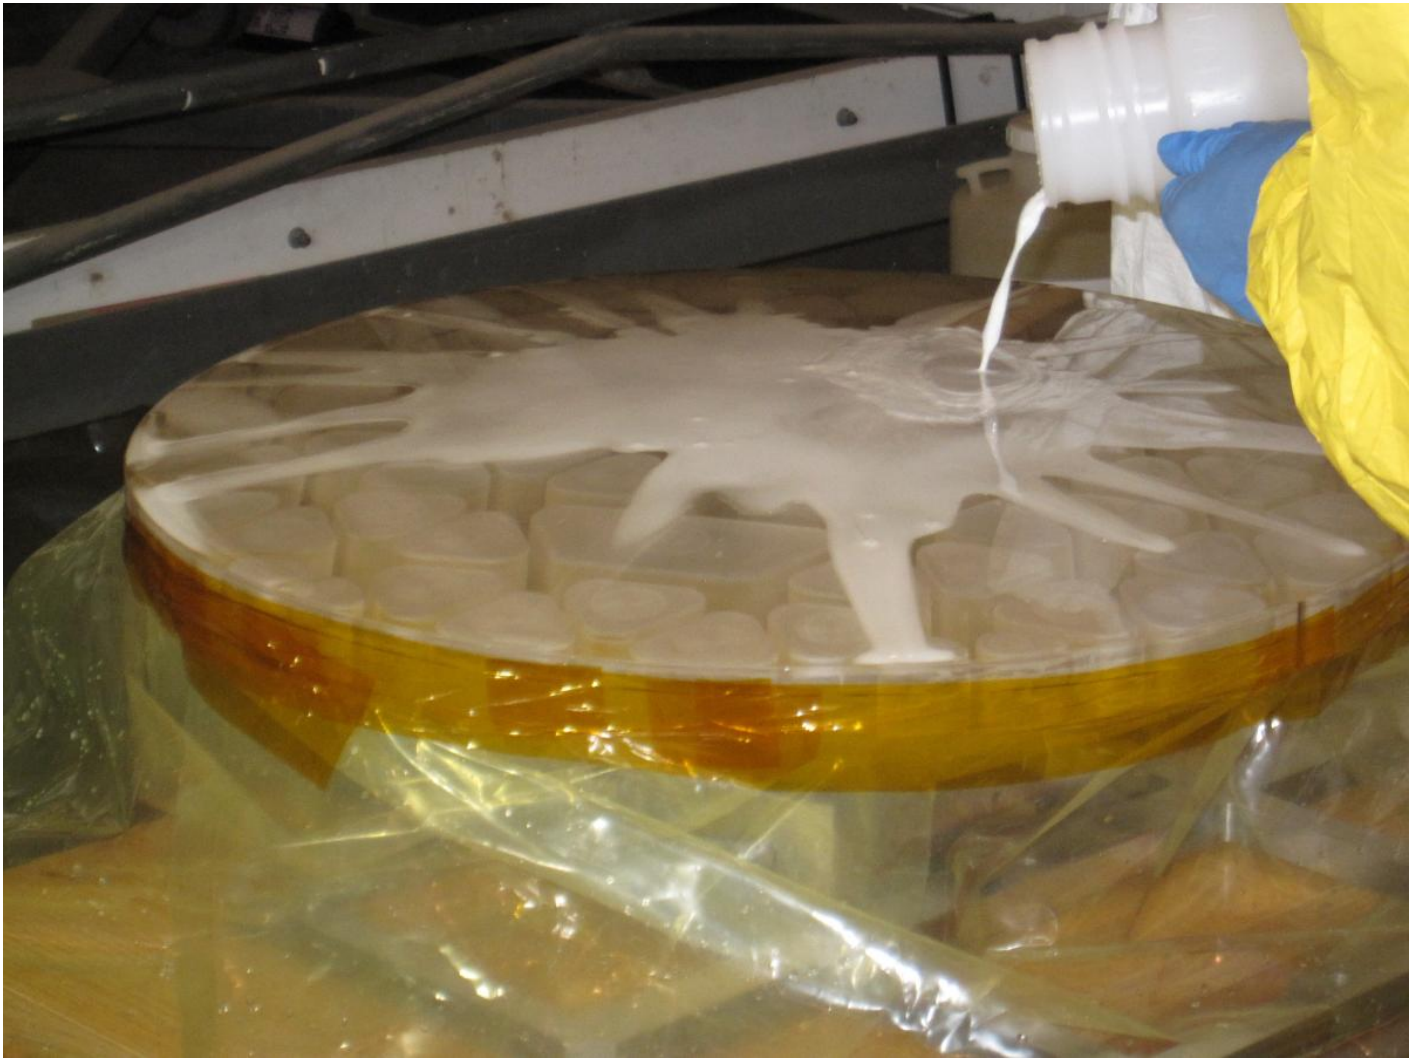
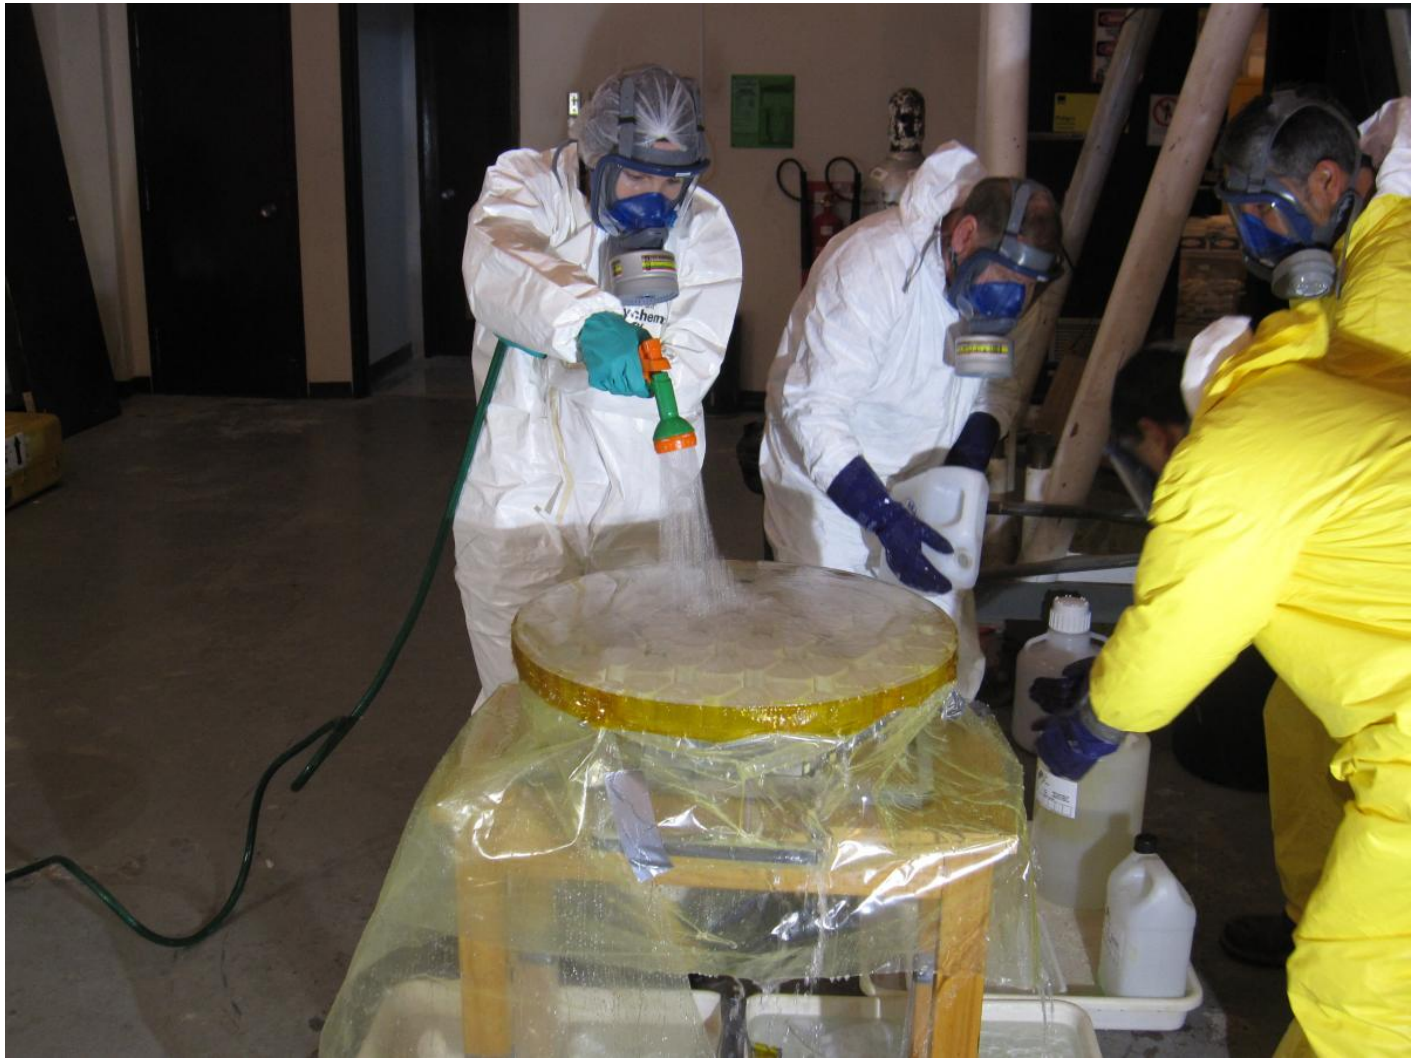
The mirror is prepared for stripping, and then the aluminum is removed in several steps, including multiple rinses (M2 is shown in the photos below). Aluminizing crew in top right picture, clockwise: Nicole David, Roberto Tighe, Juan Andrade and Guillermo Dubo. Patricio Ugarte in lower right picture.

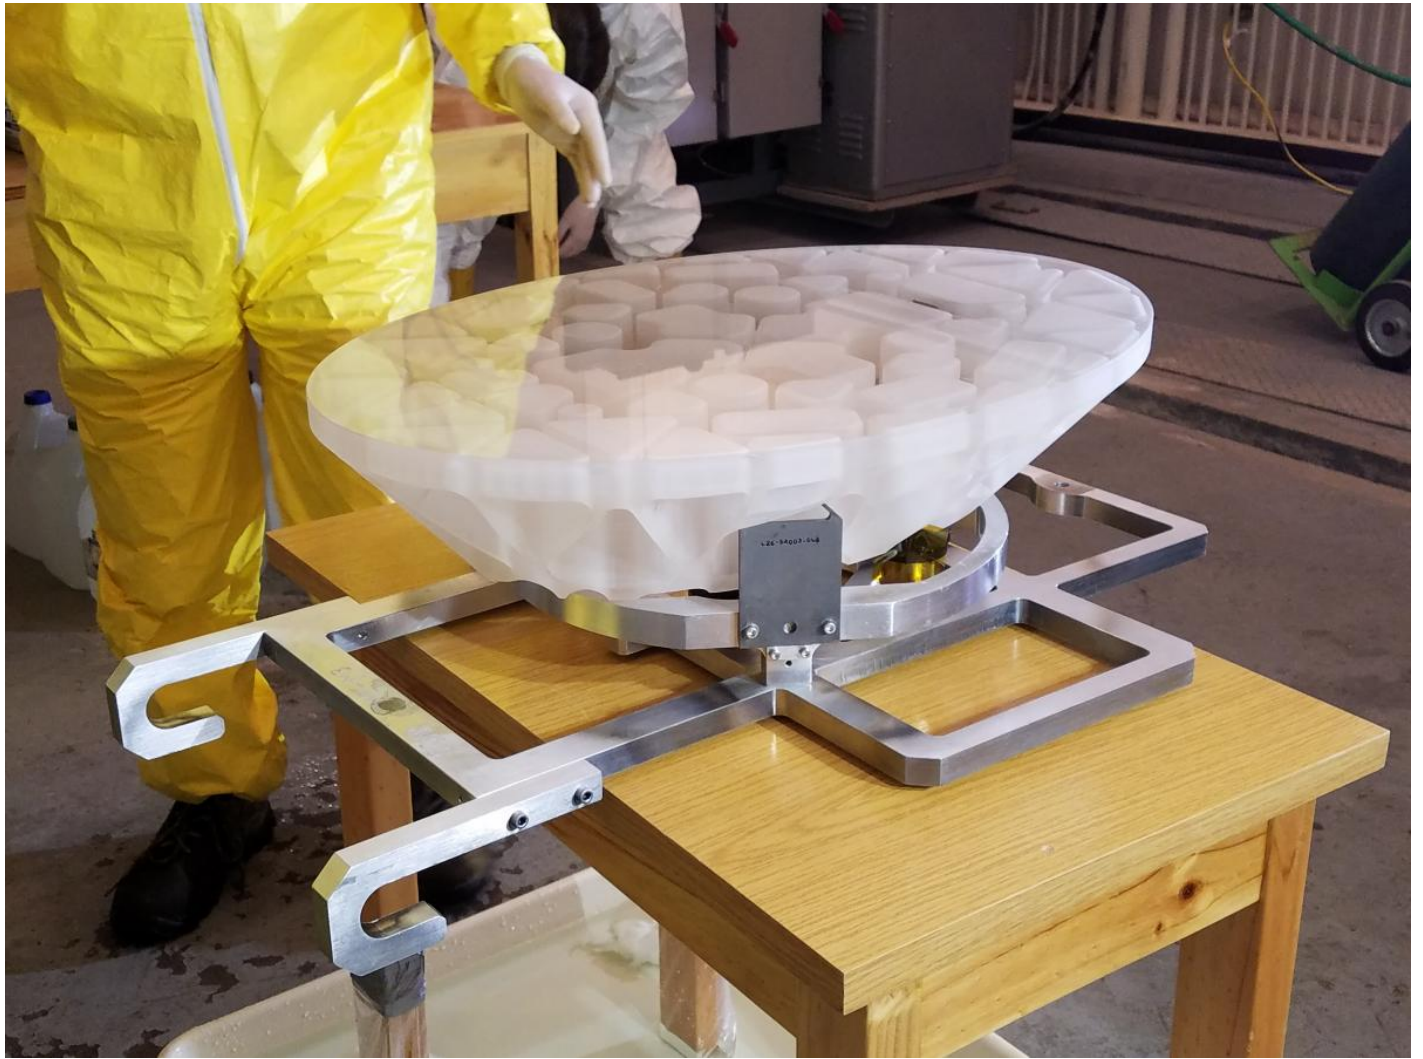
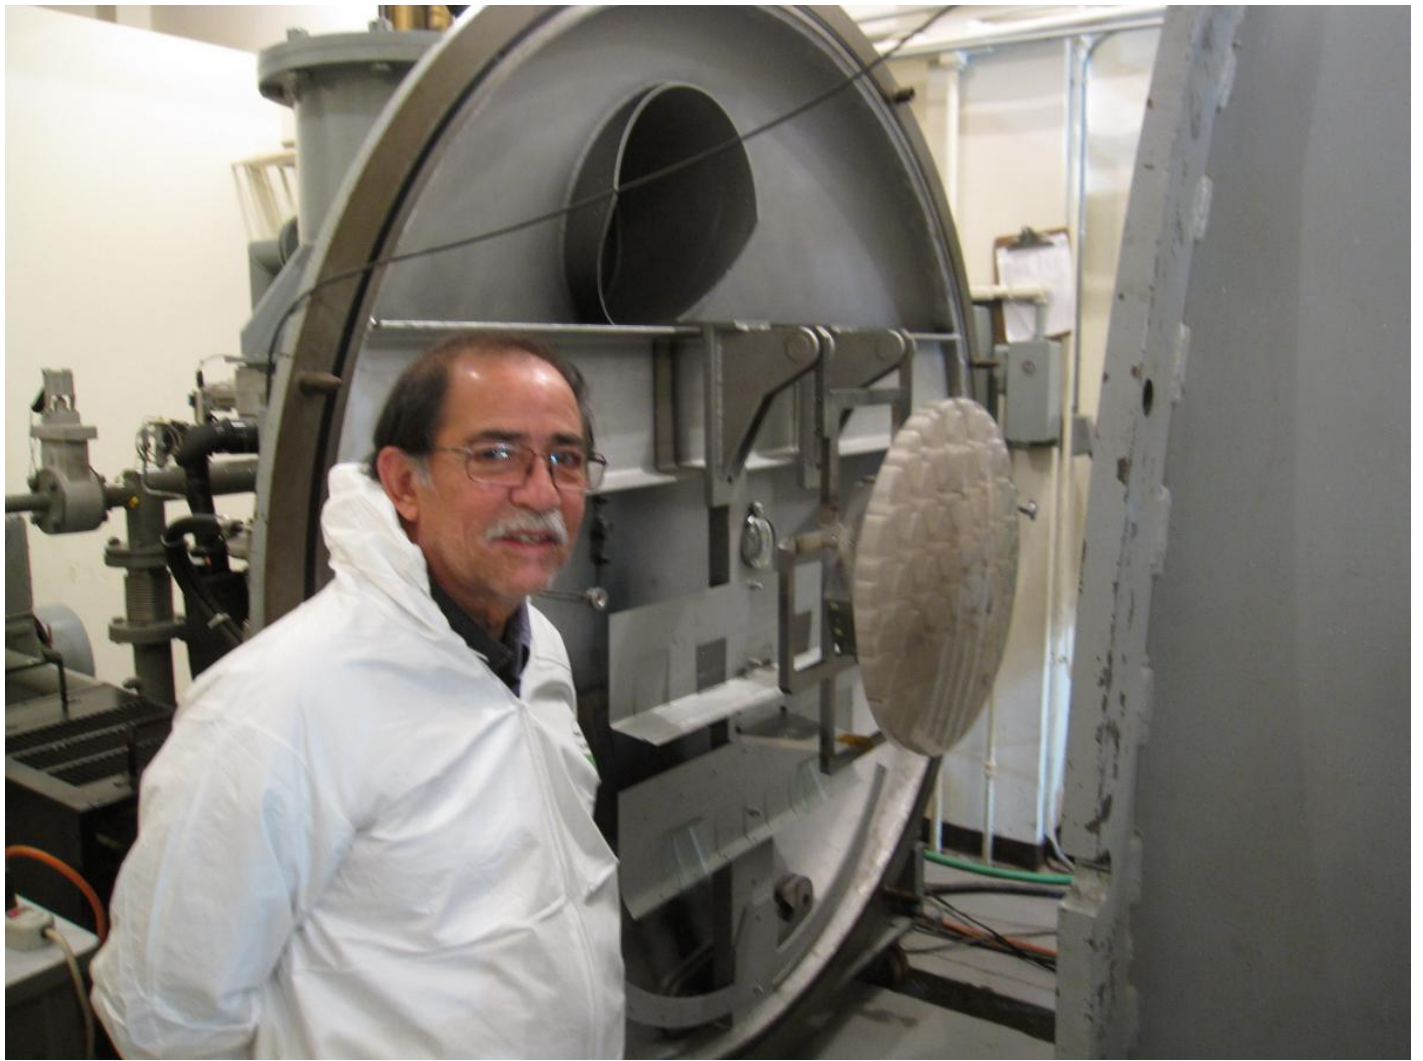
The mirror is then inspected and installed in the coating chamber (M3 on left below, M2 in righthand picture)

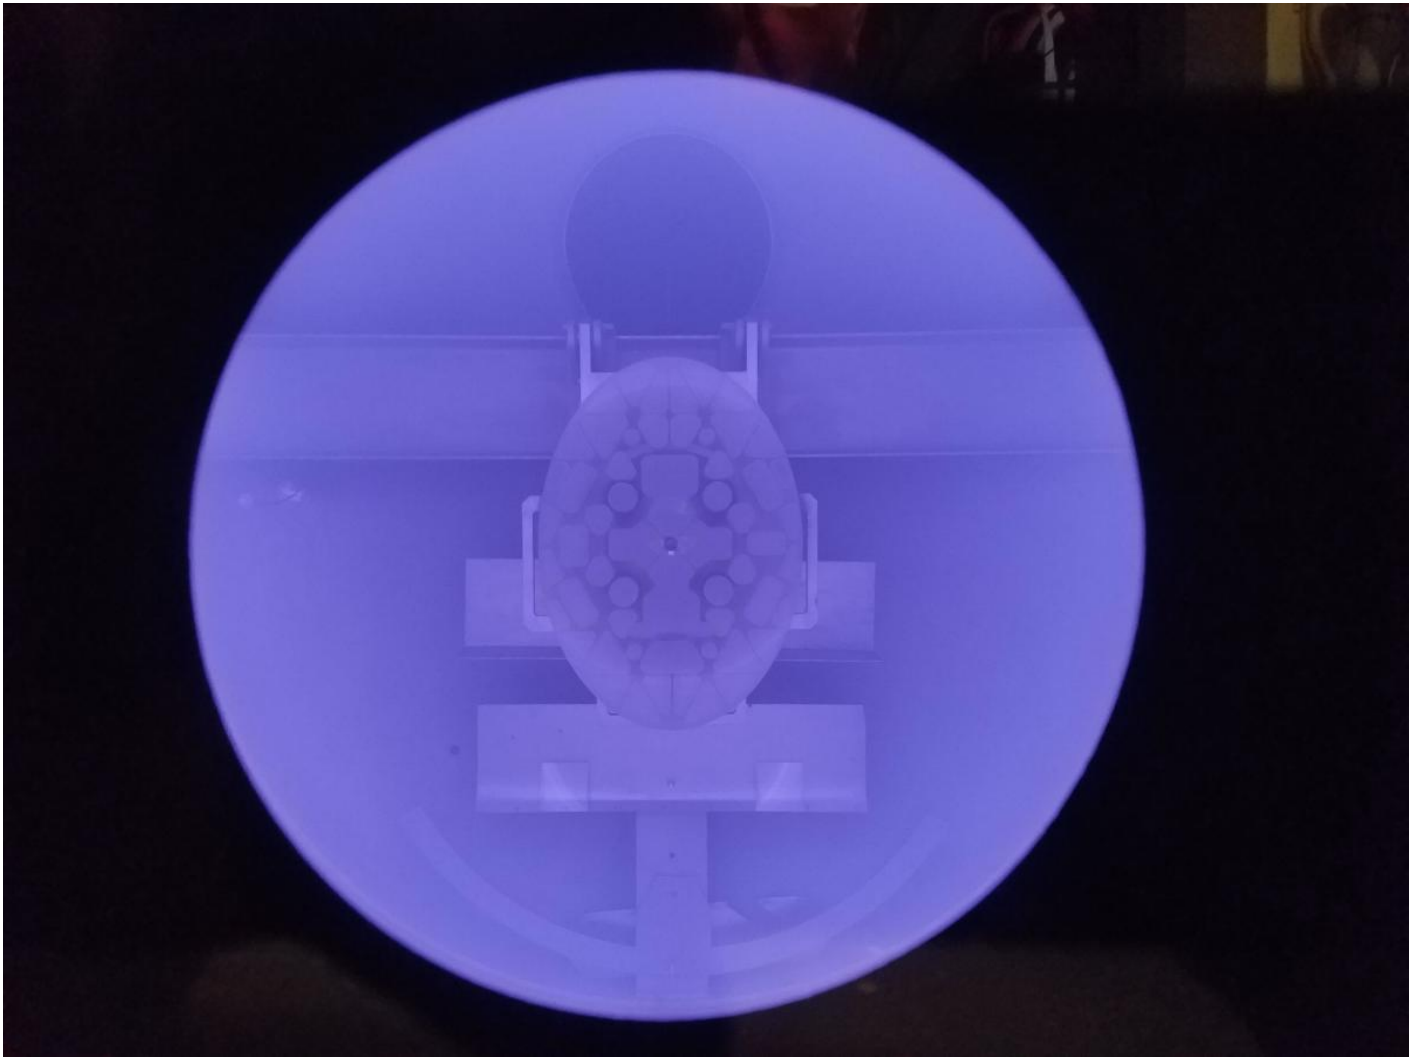
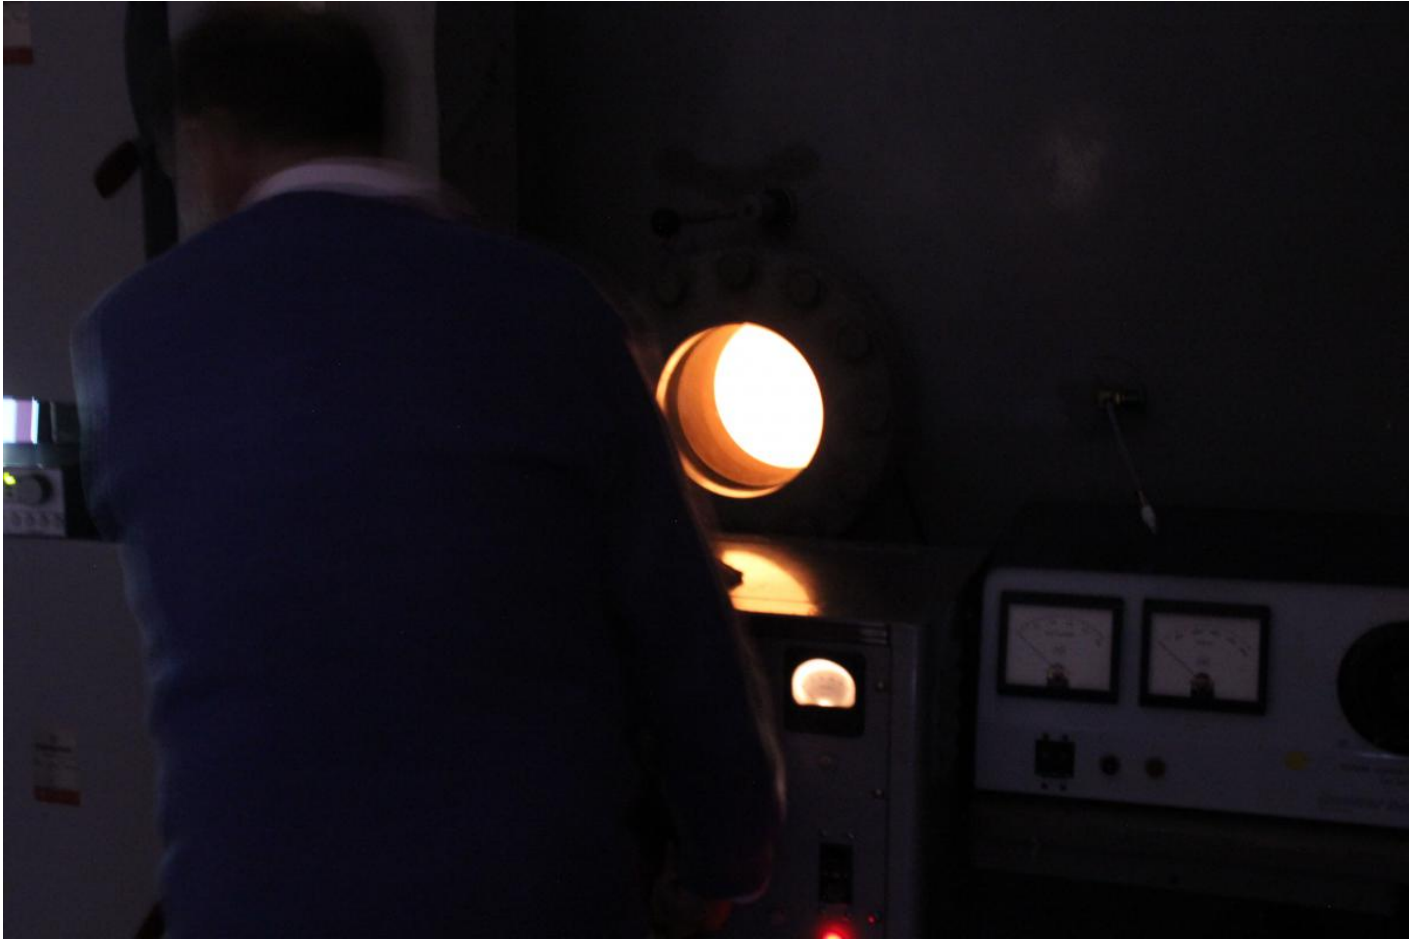
The pictures below show the glow discharge used for cleaning (left), and the light from the filaments when aluminum is being deposited (right) - both for M3.

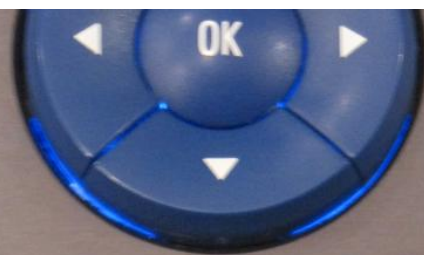
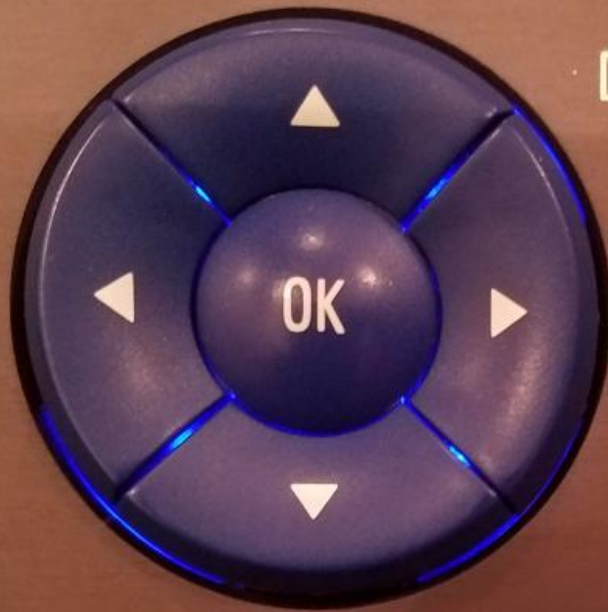
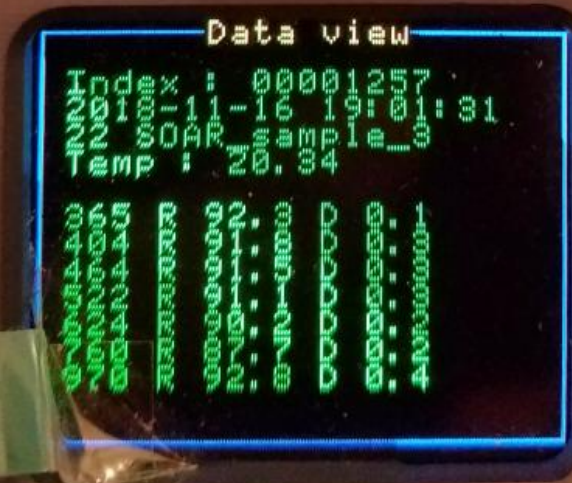
Finally, the mirror is removed, inspected, and new reflectivity measurements are taken (M2 on the left, M3 on the right):

Specular
reflectivity

7 bands from 365nm to 970nm

Data view
Index : 00001242
2018-11-14 23:10:01
21 SOAR sample_2
Temp : 19.41
365 0 92.4 0 0.1
404 0 91.6 0 0.0
464 0 91.7 0 0.0
522 0 91.4 0 0.0
564 0 90.4 0 0.0
750 0 87.6 0 0.0
970 0 92.4 0 0.4

- First, for reference, the mirror is cleaned and a reflectivity measurement is made.
- The aluminum is removed. The solutions involved can produce fumes so protective gear is required in addition to good ventilation.
- The mirror is placed in the coating chamber, together with witness samples.
- The chamber is pumped in several stages, including a glow discharge used for cleaning and a diffusion pump that runs for several hours to produce a good vacuum.
- The filaments carrying the aluminum for deposition are turned on to deposit the coating.
- The chamber is brought back to atmosphere after a nitrogen back-fill, and the mirror is inspected and the reflectivity is measured.
- If the coating is not good enough, the process would be repeated; for both M2 and M3 the first coating was excellent.

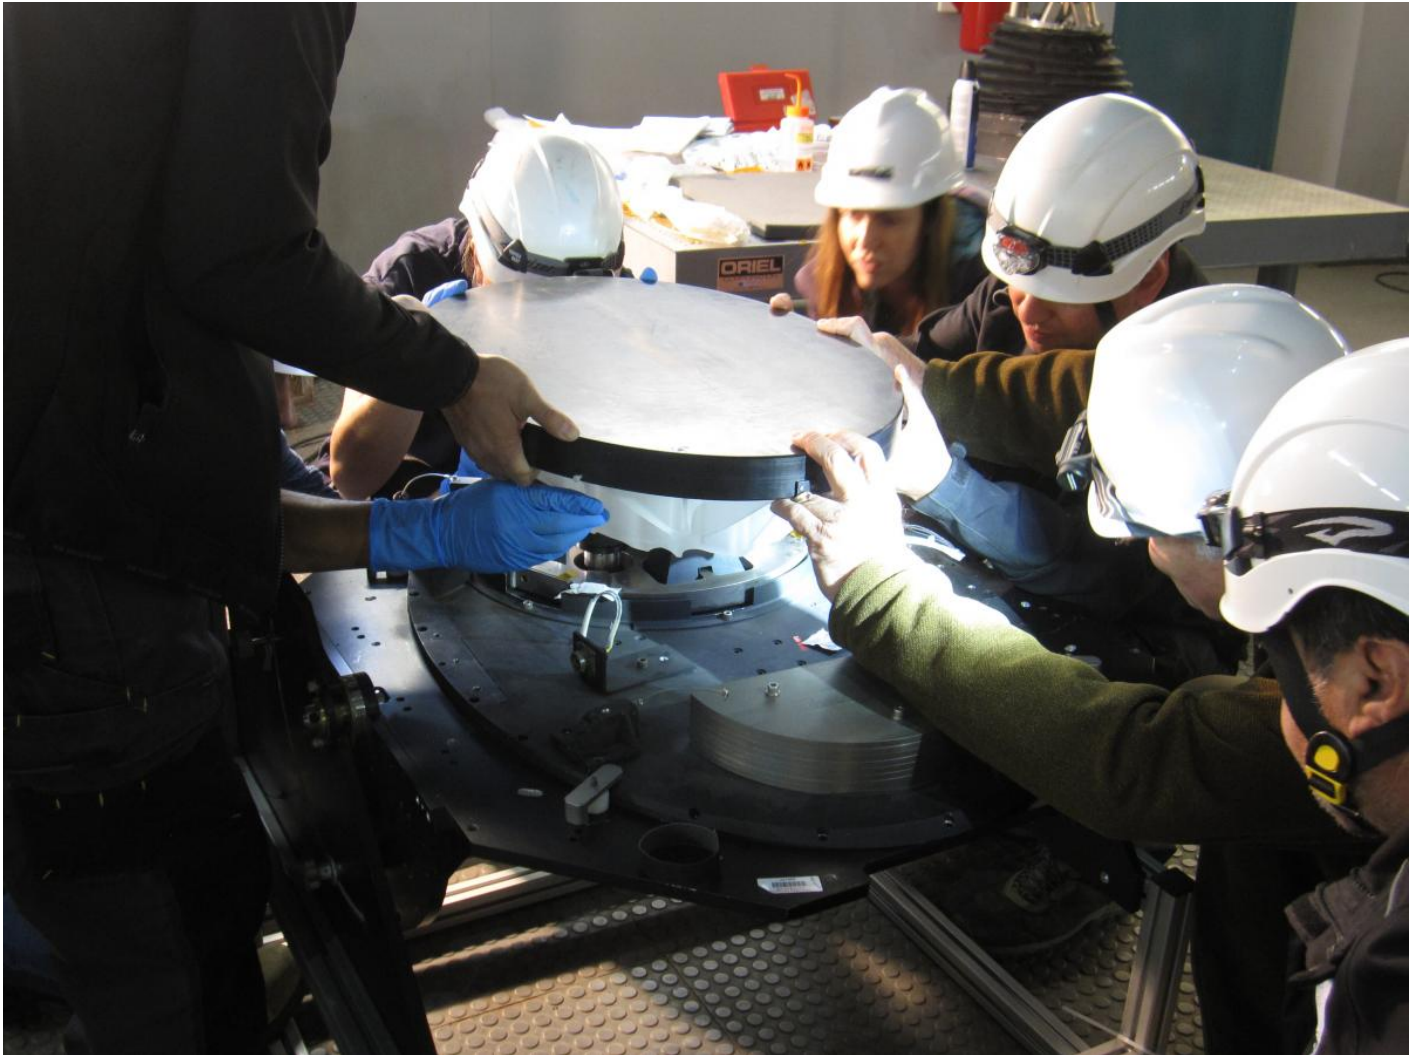
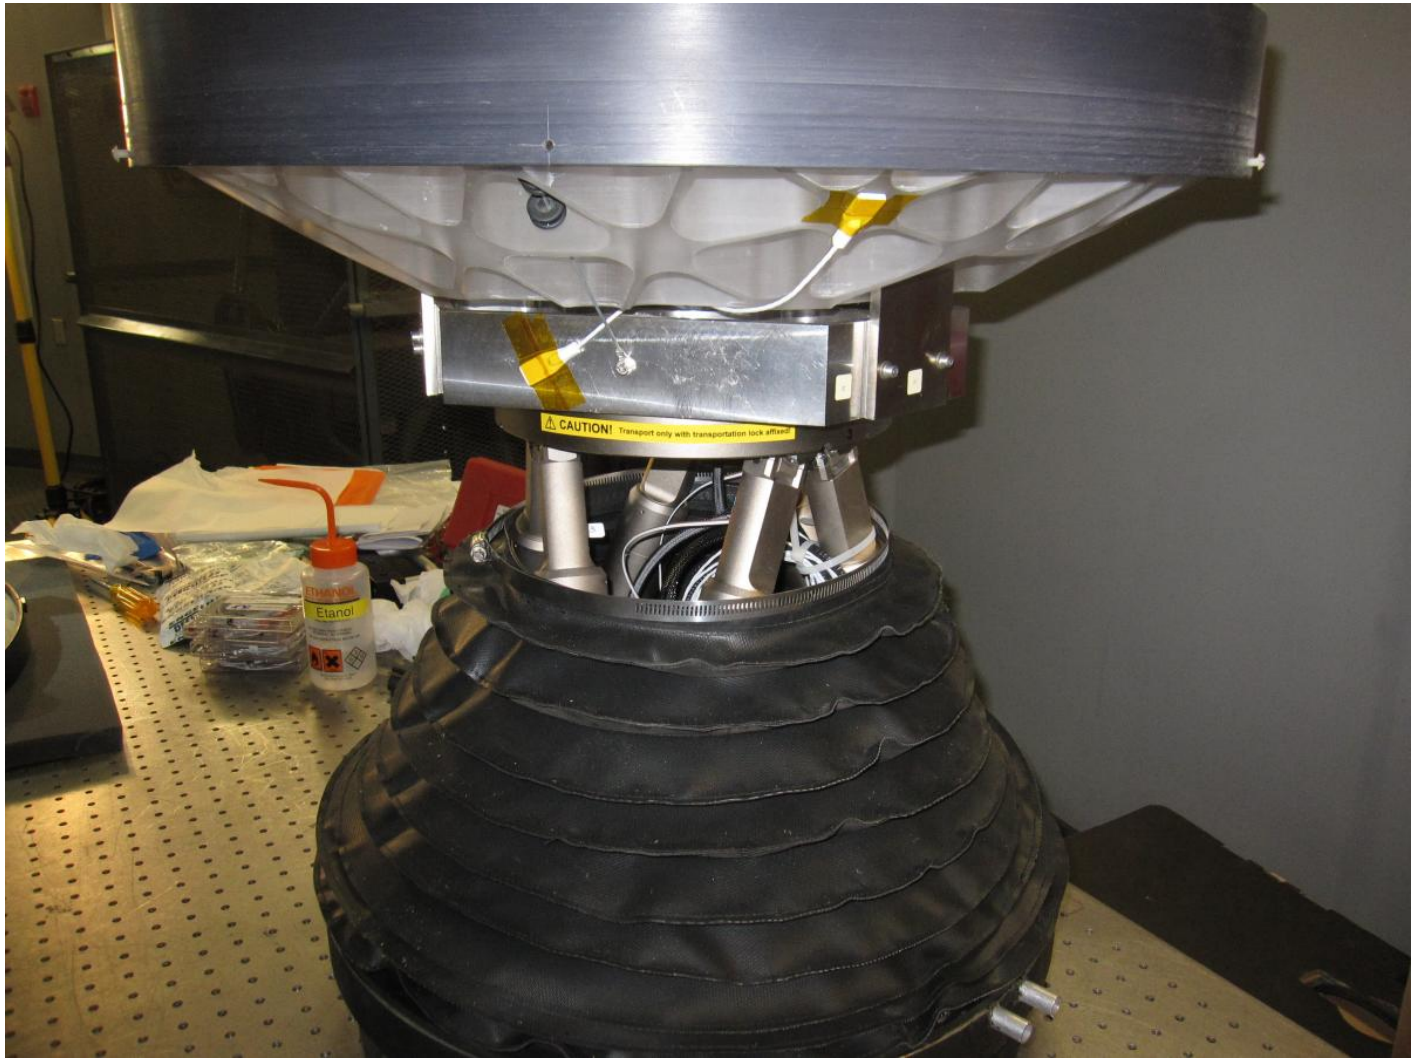
The image on the left shows M2 (with cover) back on the assembly; the image on the right shows M3 being re-installed on its actuators.

The next steps require re-installing the mirrors on their mechanical assemblies - the M3 assembly also needs re-alignment and a check of servo operation for the tip-tilt capability.

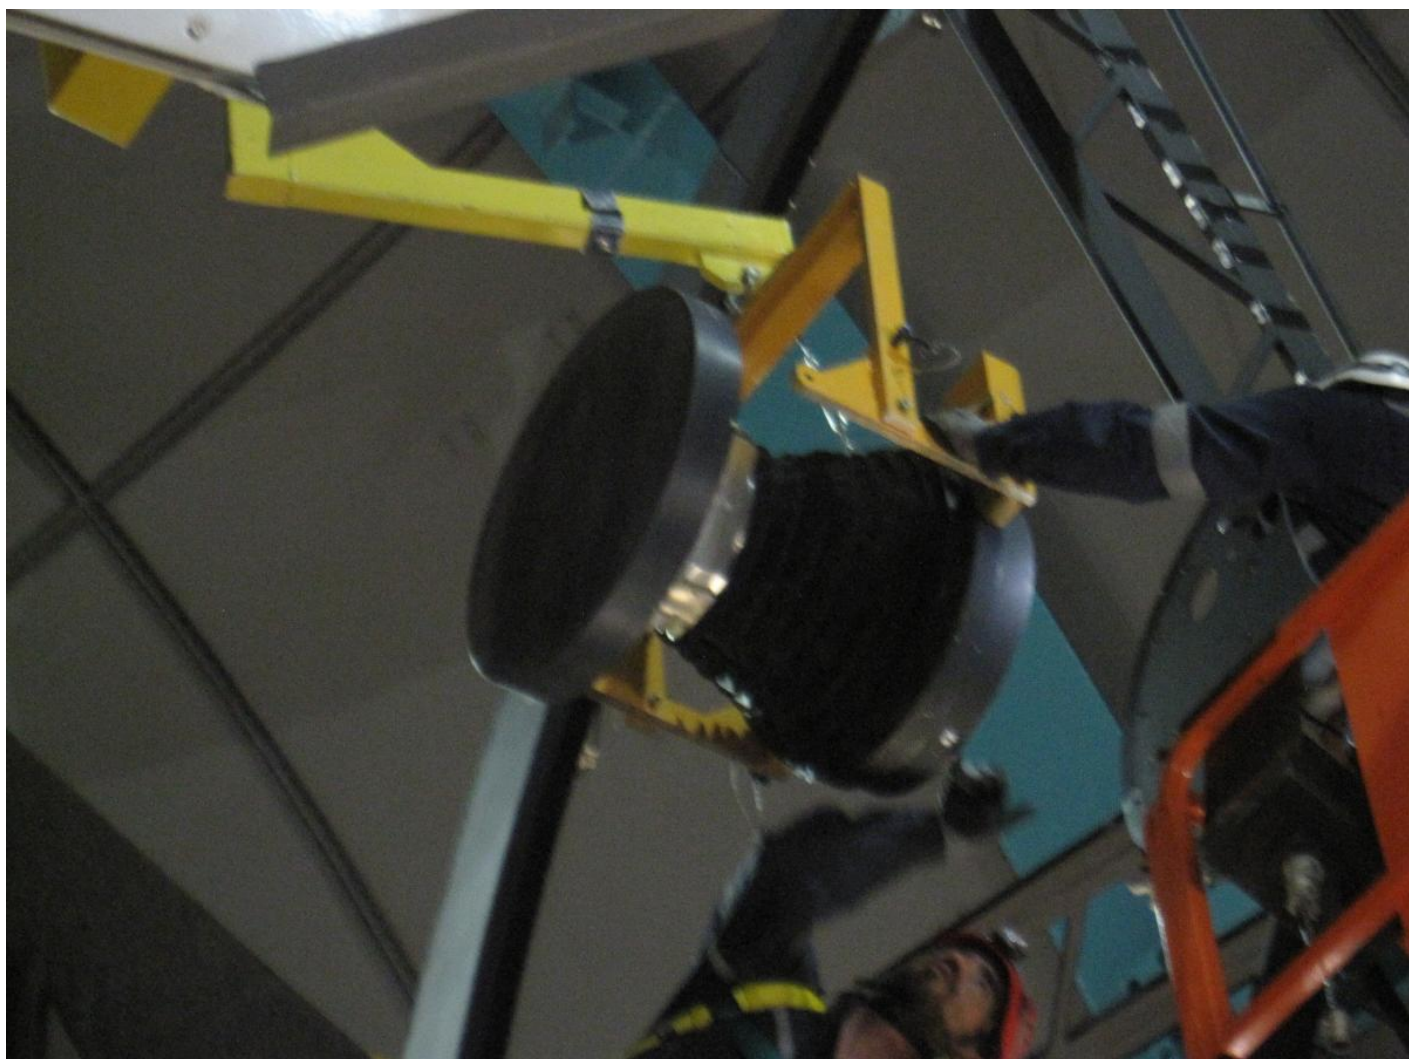
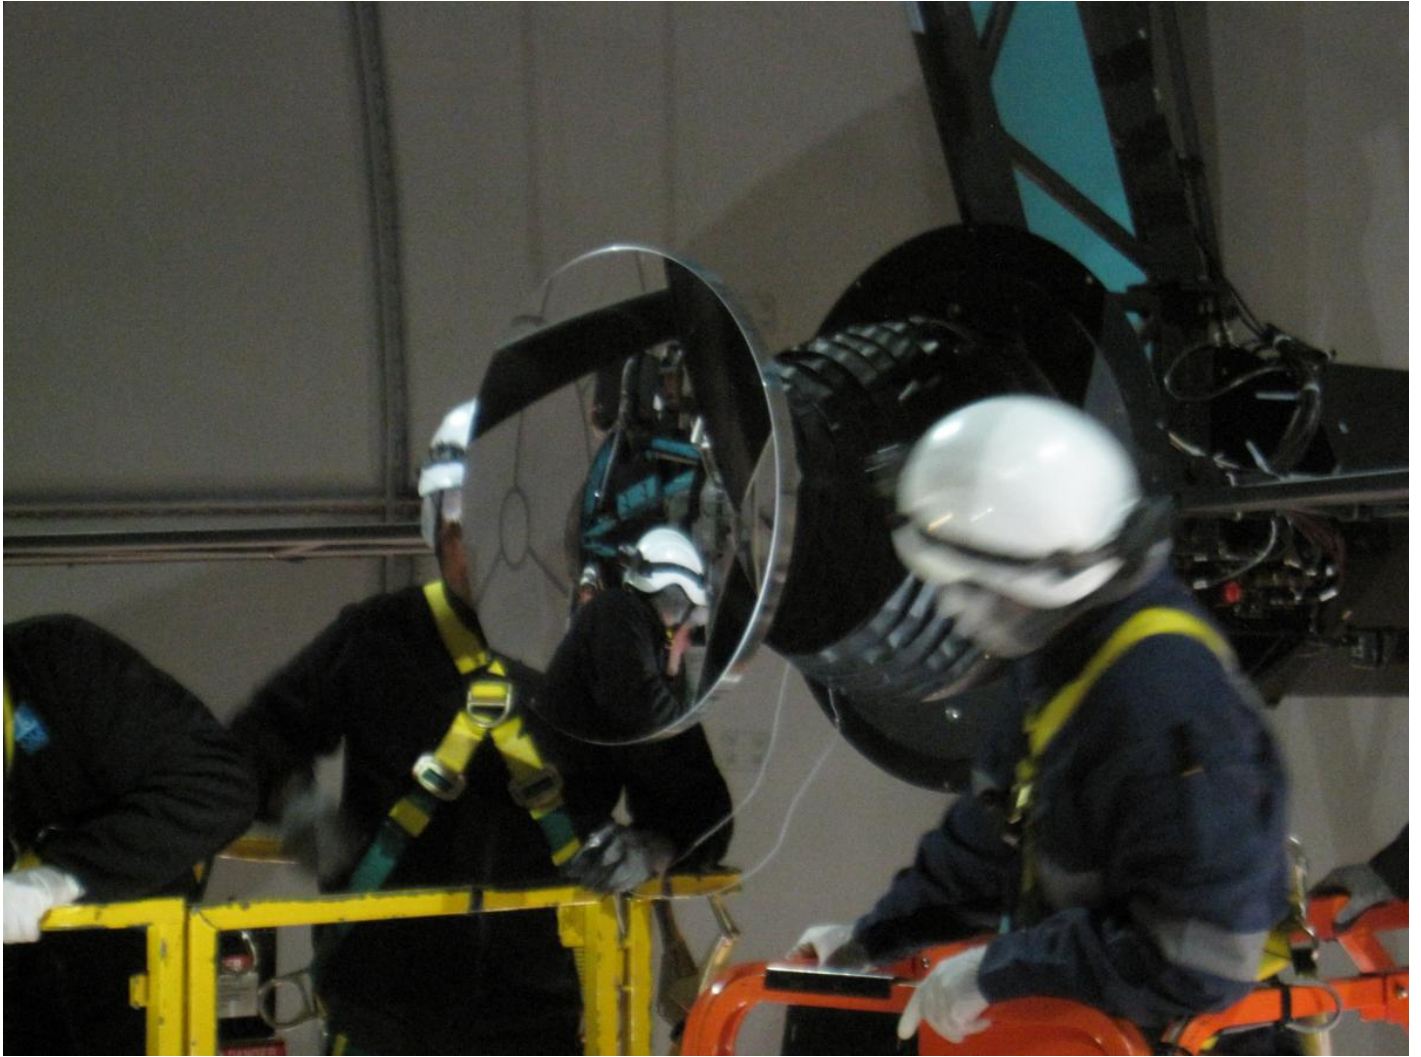
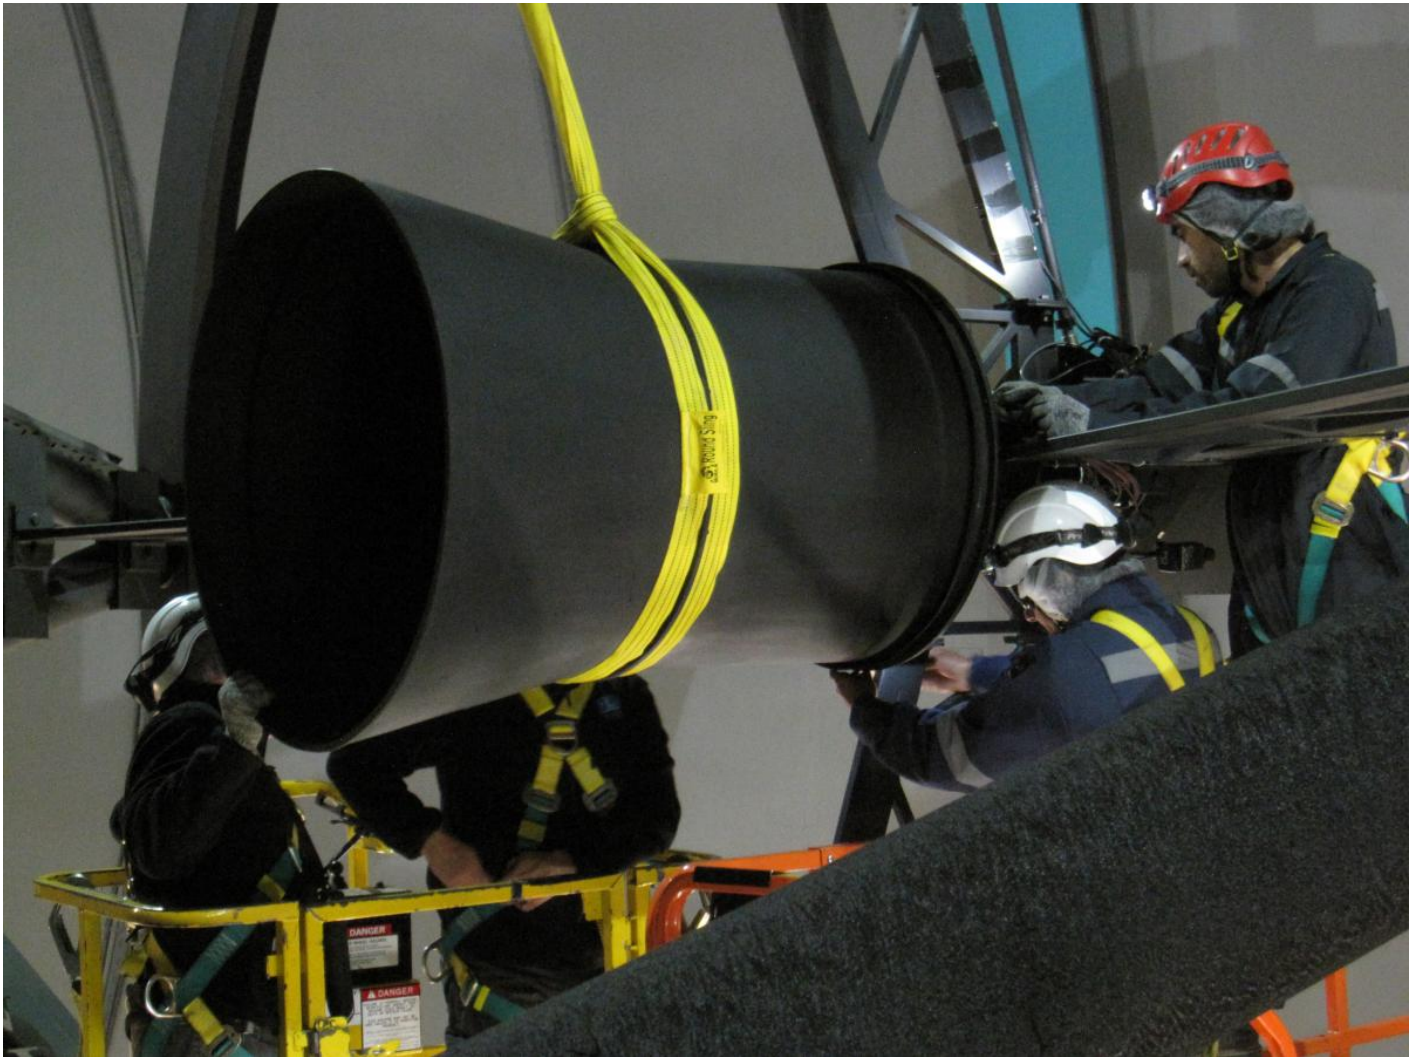
The first picture shows the assembly just before attachment to the top end. The next shows the assembly with the cover removed, just before installing the baffle. The baffle is being installed in the final picture.

The re-installation of M2 and its baffle took place over two days, for operational convenience; here the complete sequence is shown:
