SOAR 2018 Shutdown Details

Last update Nov. 20, 2018

M2 Removal

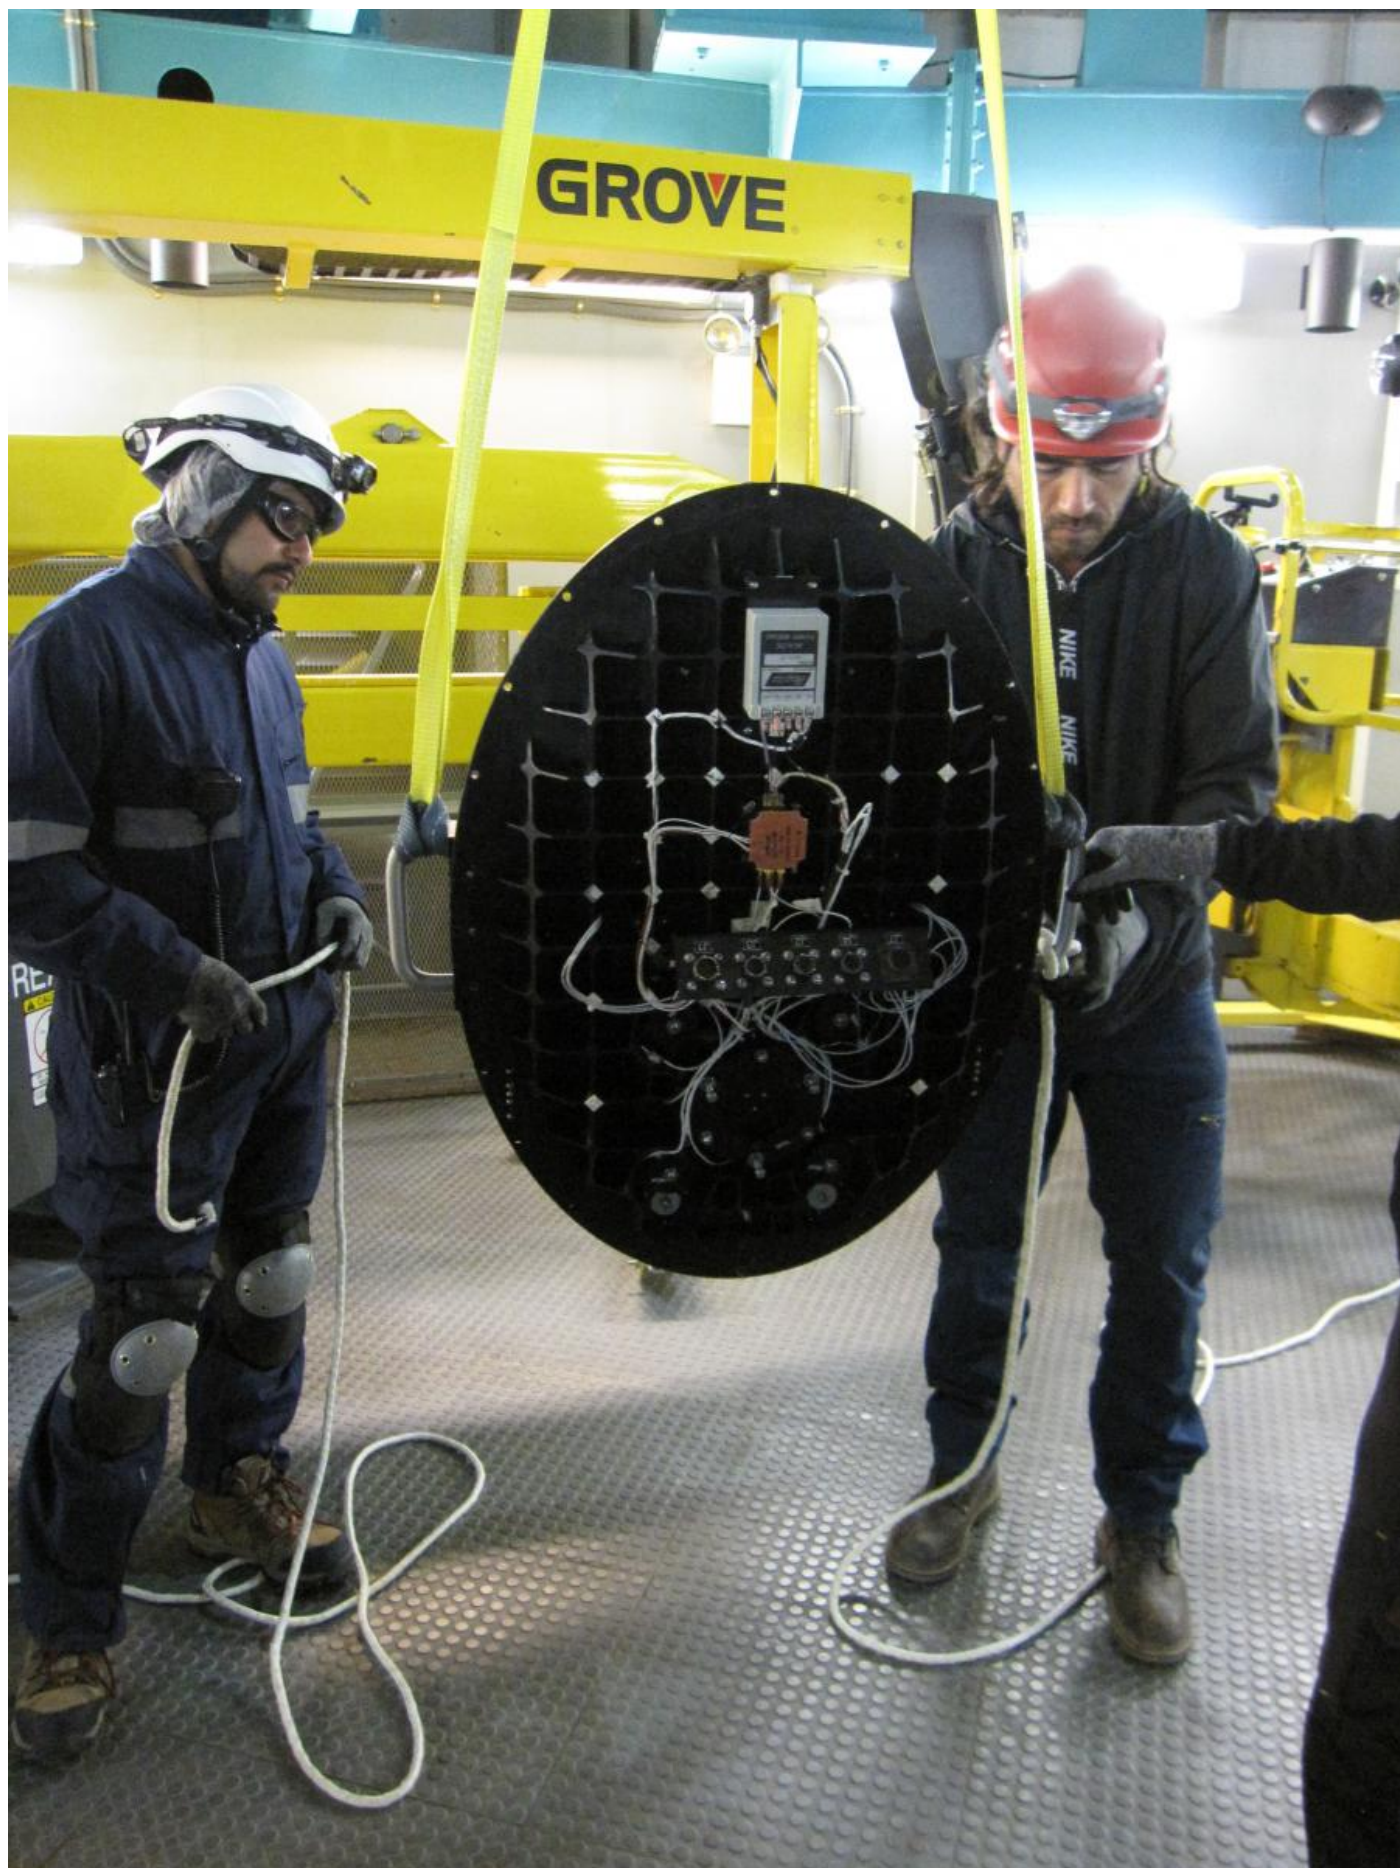
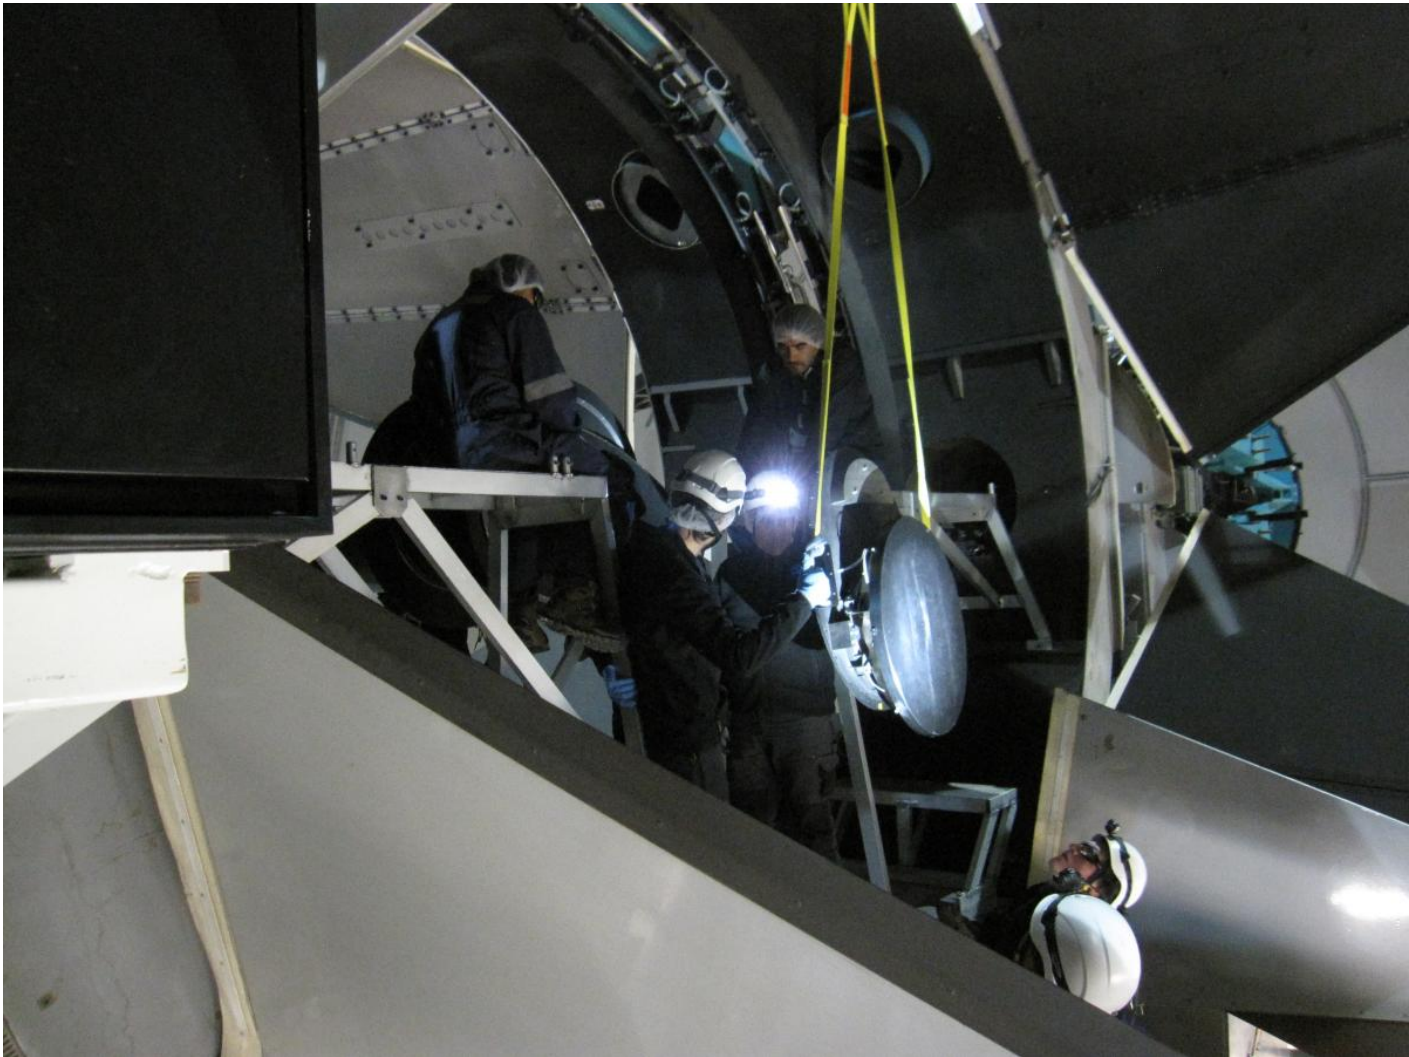
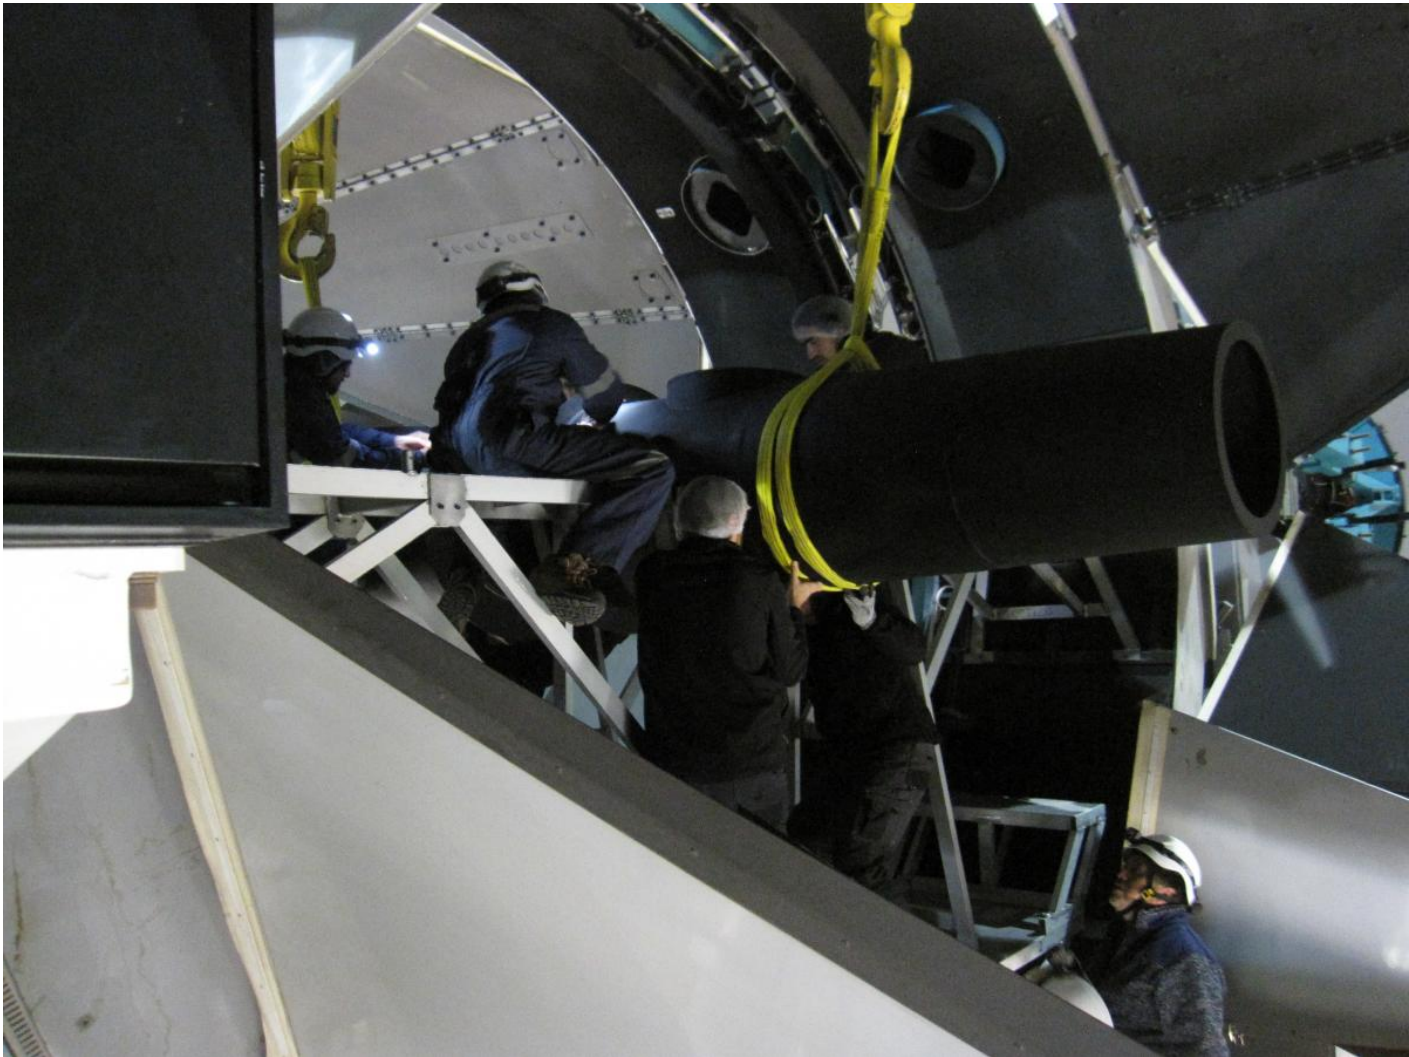
The process for re-installing M3 is generally similar, as shown in the pictures below. The first shows the assembly being lifted for installation. The next two show the assembly being positioned on the end of the M3 turret, and then the baffle being moved over the end of the turret.

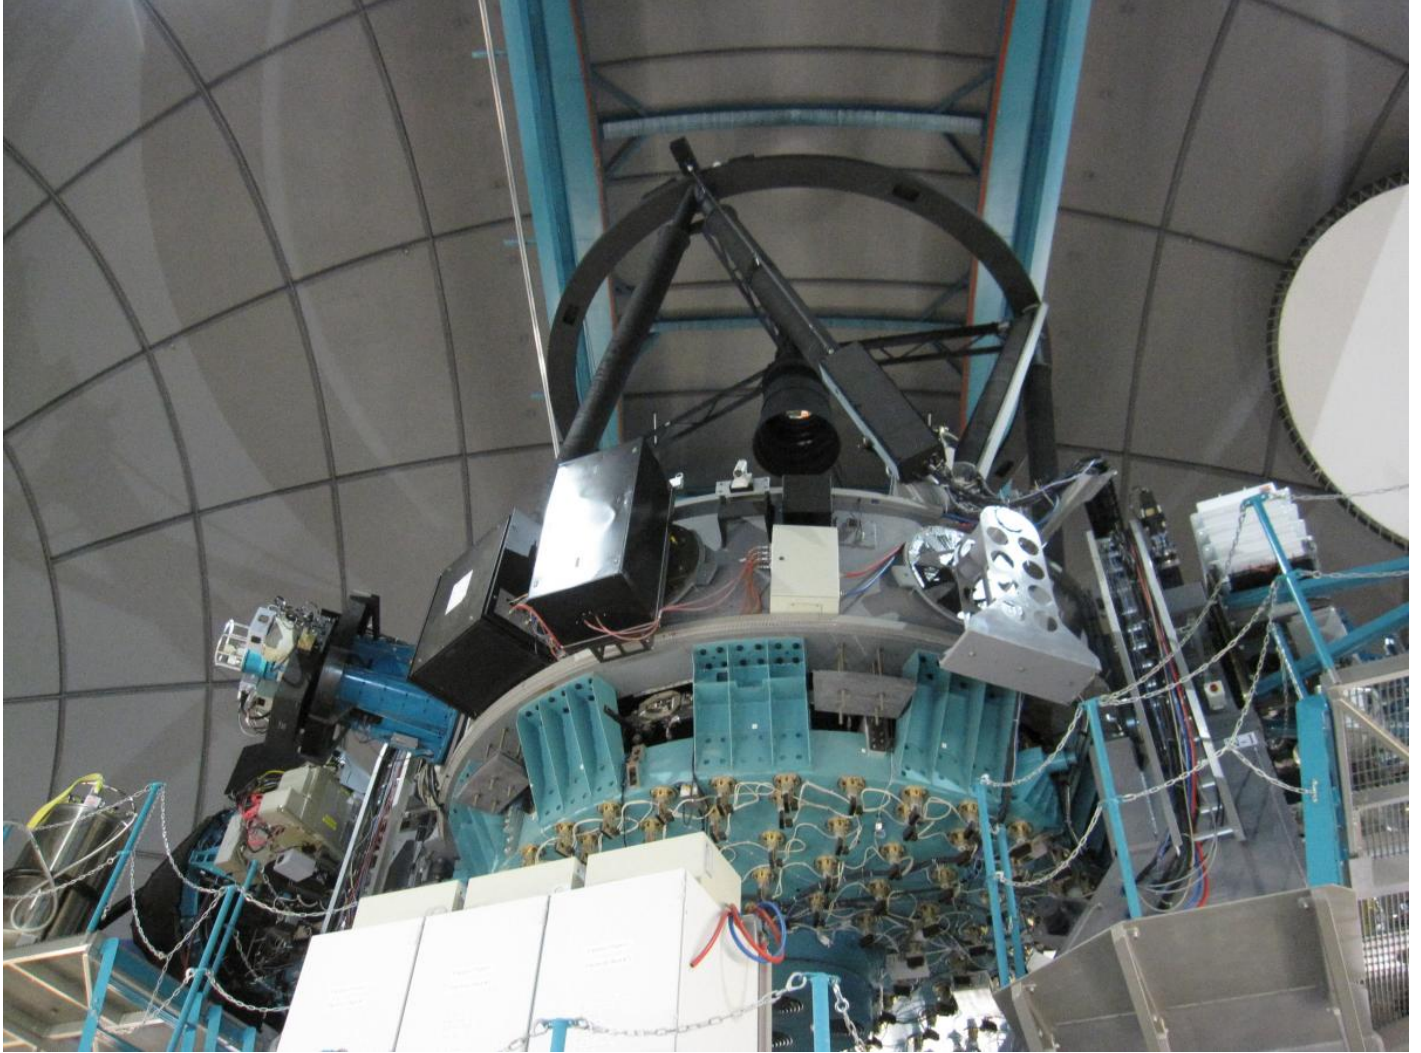
The telescope elevation motion is enabled and check-out begins.
