Earthquake Impact at SOAR - updated

Submitted by jalias on Thu, 2015-09-17 16:17

Final update October 3

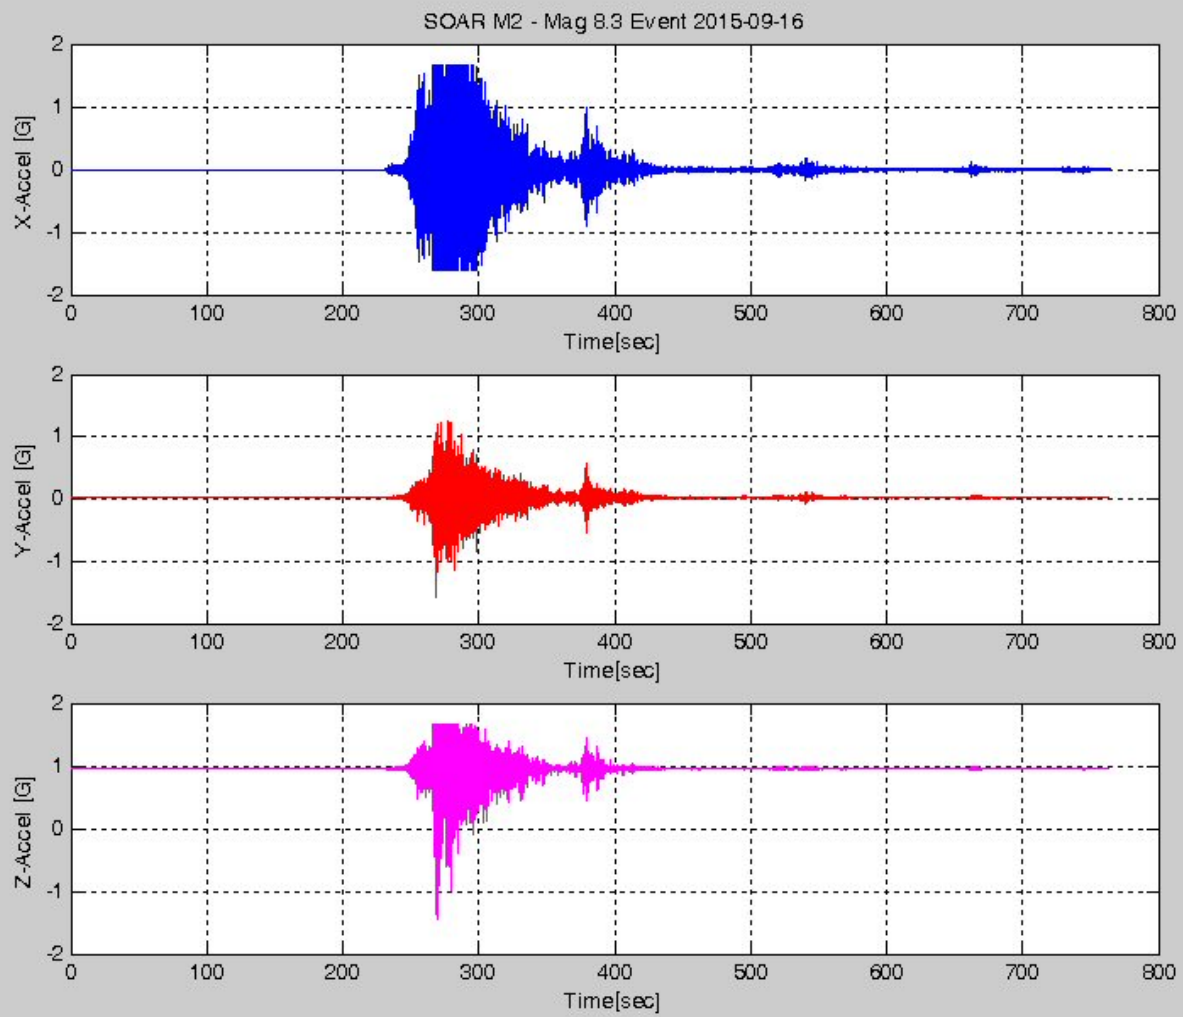
The plots below show the accelerometer readings from the pier and the secondary mirror assembly during the main earthquake event. Analysis is not complete, but results from an earlier event indicate that the amplification from the pier to the secondary can be as large as a factor of 30 at resonant frequencies of the secondary assembly.

Accelerometer readings from SOAR pier (top) and M2 assembly (bottom). Note that the forces exceeded the saturation point on the M2 accelerometer for both the X and Z axes.
